# MELVIN RIVER ASSESSMENT | REPORT

**TO:** Pat Tarpey and Bree Rossiter, Lake Winnepesaukee Association  
**FROM:** Sarah Large, FB Environmental Associates (FBE)  
**SUBJECT:** [Melvin River Assessment](#)  
**DATE:** January 19, 2024; revised March 15, 2024  
**CC:** Forrest Bell and Maggie Mills, FB Environmental Associates (FBE), James Woitdt, Streamworks PPLC

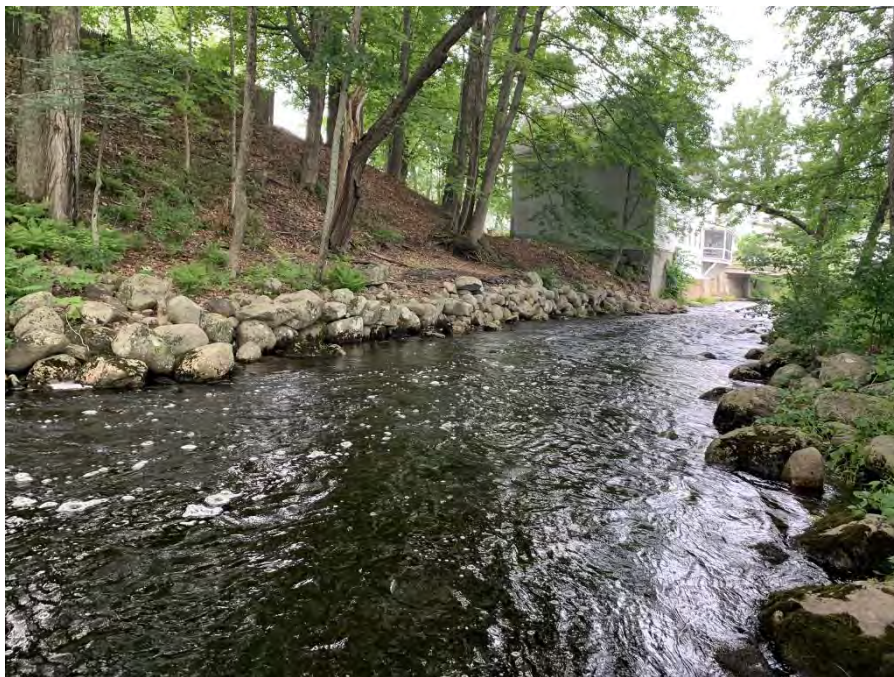
Photo 4. Dry-stacked boulder and concrete retaining walls line the banks of the lower segment of Reach 1.

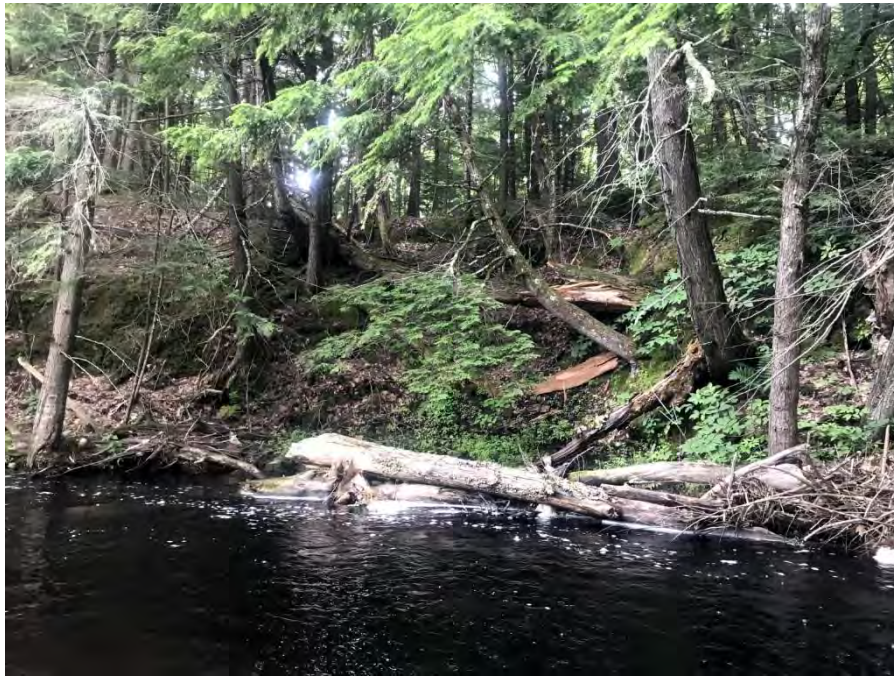
Photo 11. Severe erosion along the river's right bank immediately downstream of the County Road Crossing.

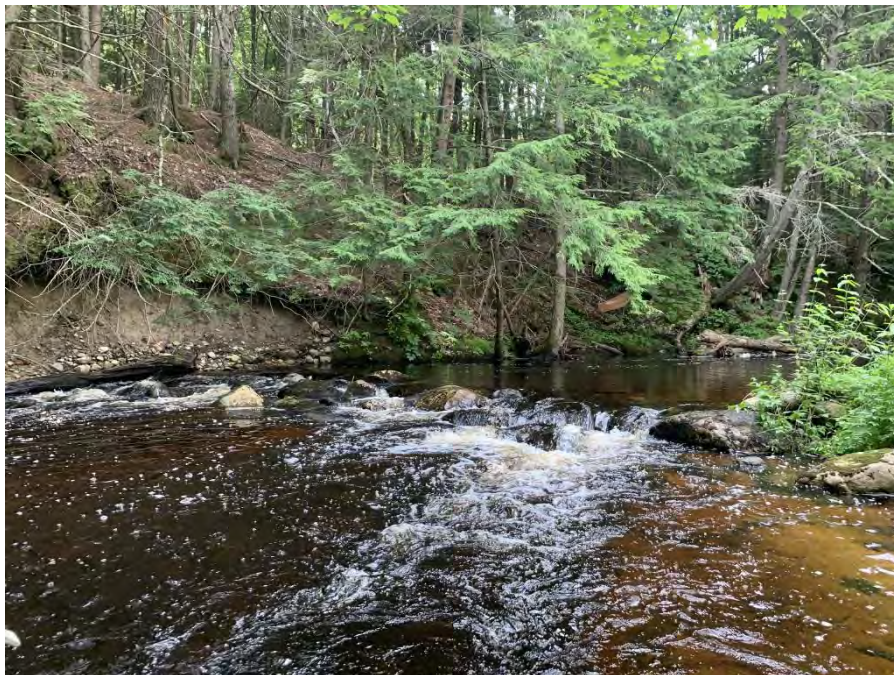
Photo 12. Bank scour that if left unaddressed possess a landslide risk resulting in a large addition of sediment.

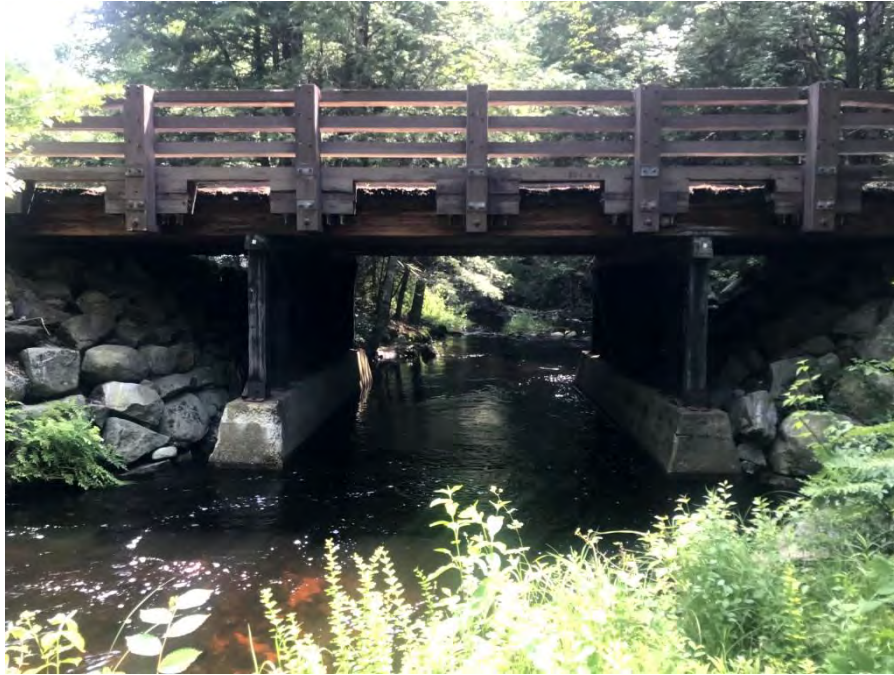
Photo 13. The County Road Crossing is an undersized open-bottom bridge with poor stream alignment.

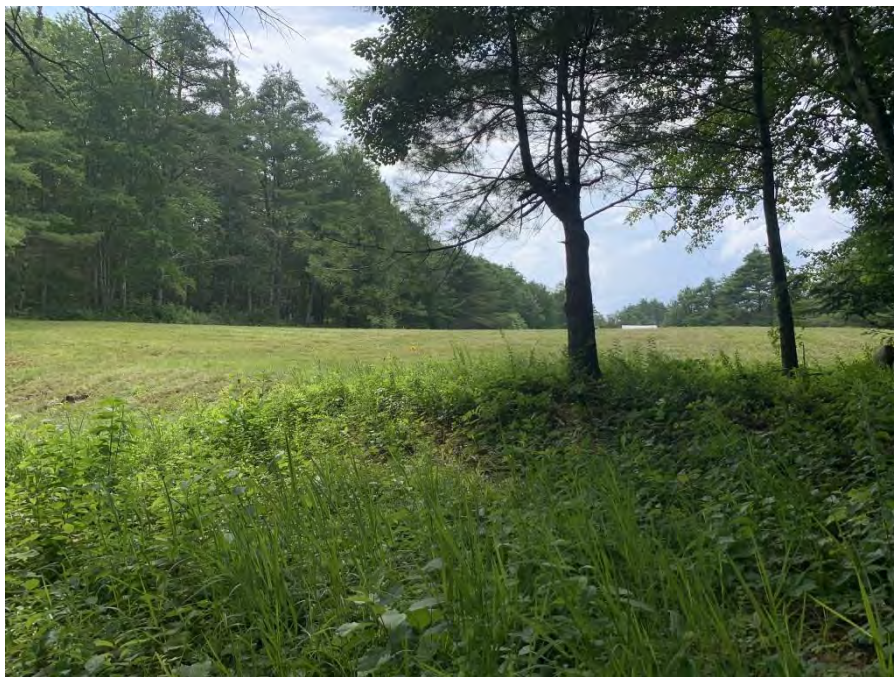
Photo 14. There's a narrow, forested buffer between a large, mowed field and the river in a few locations along Reach 1, 2a, and 2b.

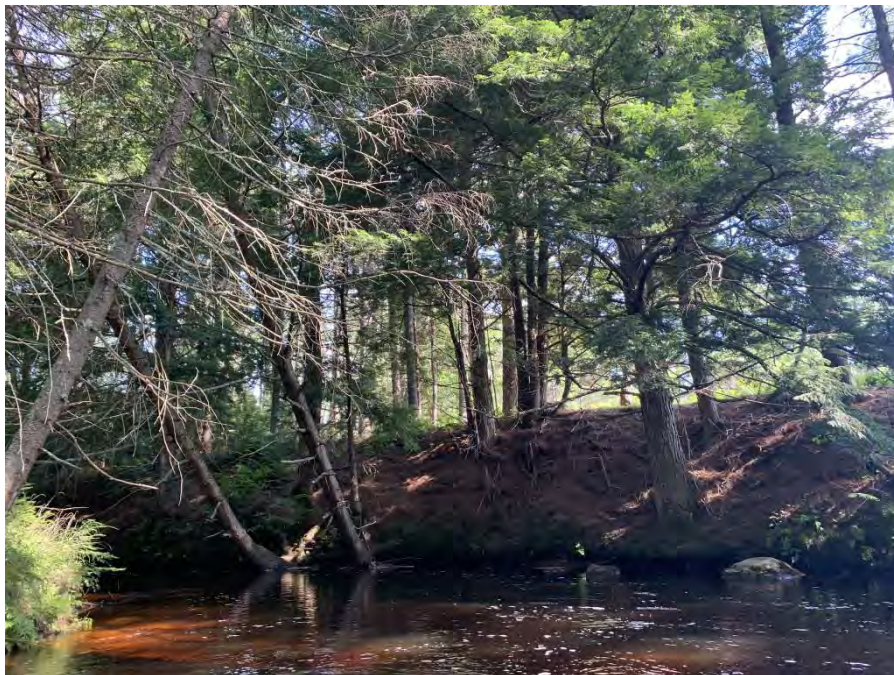
Photo 18. A bank vegetated with eastern hemlock (*Tsuga canadensis*) slumping into the river, a result of erosion at the toe of slope along a meander bend within Reach 2b.

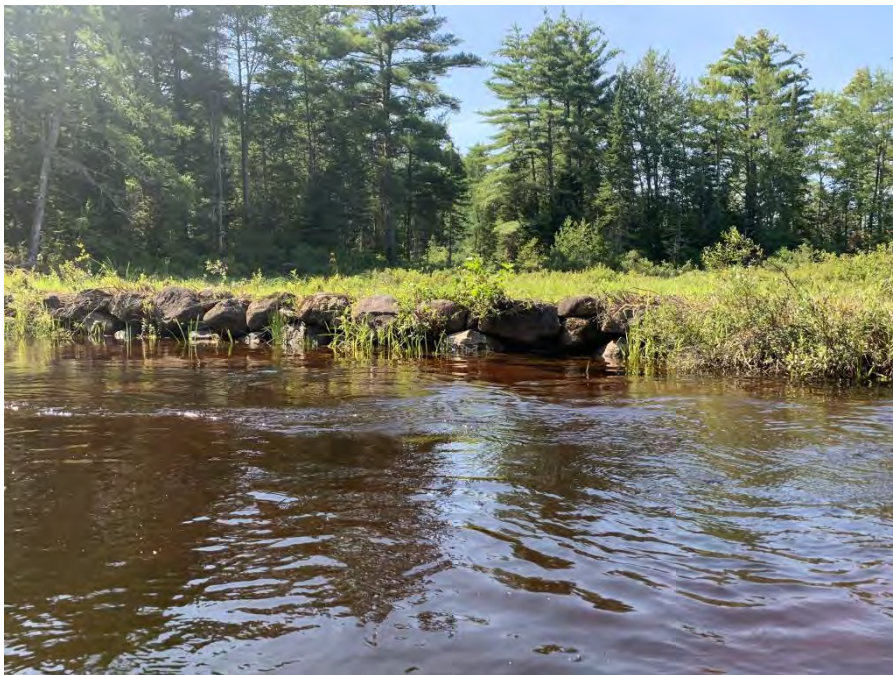
Photo 20. Newly cleared riverbank and boulder revetment along Reach 2b.

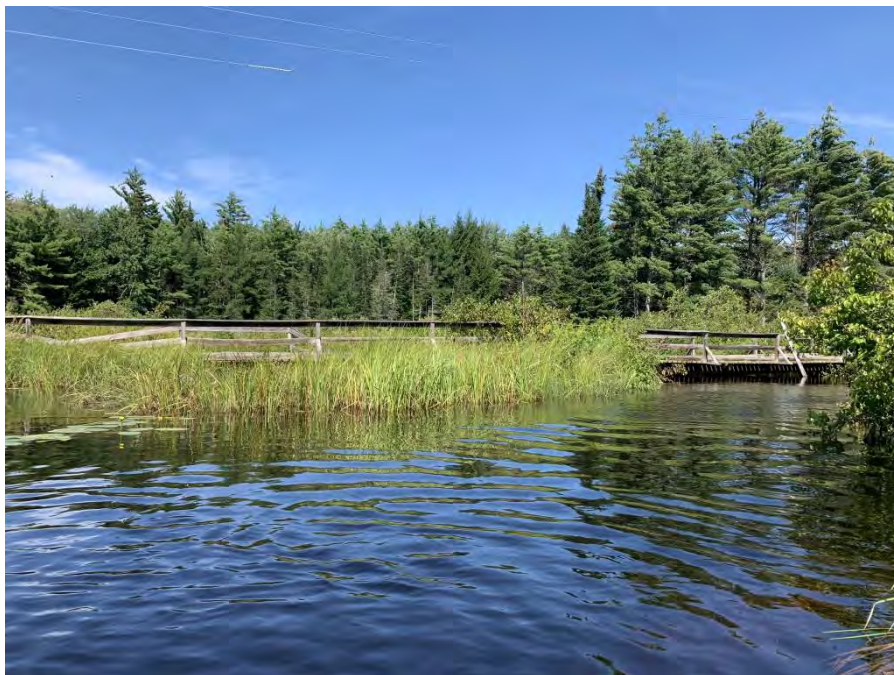
Upgrades and improvements at each of the stream crossings located along the study reach will improve the ecological condition and connectivity of the Melvin River. Concurrent to the Rapid Habitat and Geomorphic Assessments, the NH Fish and Game Department (NHF&G) conducted stream crossing assessments within the study reach, following the Statewide Asset Data Exchange System (SADES)/ NH Stream Crossing Initiative's Stream Crossing Assessment Field Manual which evaluates geomorphic compatibility, aquatic organism passage, and structural condition. NHF&G completed assessments for six of the eight crossings FBE and Streamworks encountered within the study reach (Table 2). However, NHF&G was unable to access the Snowmobile Trail #1 crossing and the Private Trail bridge to complete an assessment. The structure sizes and geomorphic compatibility score for each of the evaluated crossings met the mostly compatible or fully compatible classifications, however several crossings were scored as having no or reduced aquatic organism passage. All of the evaluated crossings were deemed to be in good structural condition, besides the New Road concrete bridge which was in poor condition. The results of the NHF&G assessment generally aligned with Streamworks' observations, with only a few exceptions. Streamworks evaluated the New Road crossing to have full aquatic organism passage due to the backwater through the bridge and impaired/reduced geomorphic compatibility since the crossing does not accommodate the river's floodplain. In addition, Streamworks identified both of the snowmobile trail crossings to have reduced geomorphic compatibility due to the accumulated woody material caught on the piers of the Snowmobile Trail #1 crossing and the scour and poor alignment at the Snowmobile Trail #2 crossing. Aquatic organism passage was also reduced due to the woody material blocking flow at Snowmobile Trail #1.

Photo 24. The Snowmobile Trail #1 crossing was nearly submerged due to woody material caught on and blocking flow through the structure in addition to backwatering effects from a large beaver dam downstream.

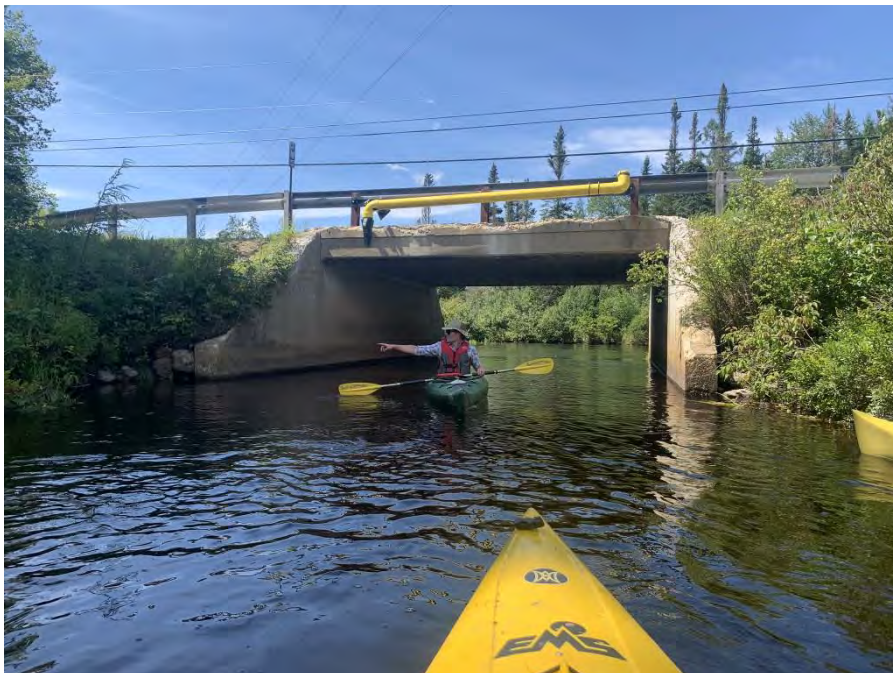
Photo 26. Reach 3 flows through a box culvert under New Road at approximately its midpoint, revealing deteriorating headwalls and wingwalls, and erosion around the structure.

Maintenance and rehabilitation of the crossings will extend their service life whereas modifications and/or upgrades at the crossings restricting connectivity will improve aquatic organism passage and restore natural stream geomorphic condition and processes. Modifications, upgrades, and improvements include adding natural streambed material through the crossings, wider span structures to accommodate the streambanks and river's floodplain, re-aligning the structure with the natural direction and flow to reduce water deflection and scour, as well as replacing crossings with open bottom spanned structures. Addressing the erosion and non-point source pollution that concentrates and enters the watercourse at this type of infrastructure is also needed.

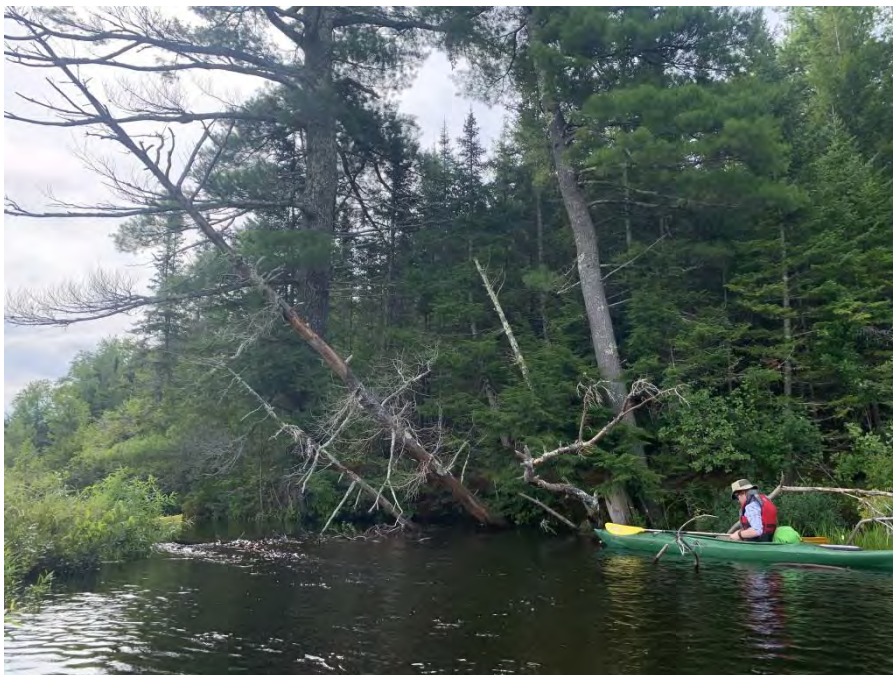
Photo 28. Bank scour causing several large trees to lean over the river, poses a potential risk.

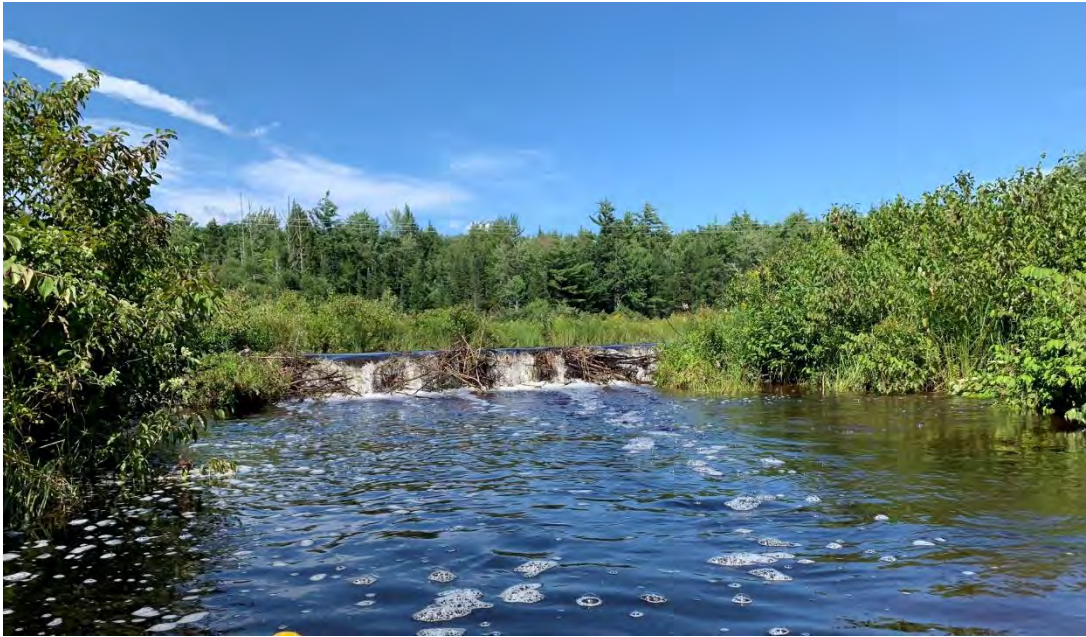
A finding that should be monitored is a very large steep beaver dam located downstream of the Snowmobile Trail #1 crossing, which is impounding a lot of water. The beaver dam was approximately 4-feet in height and backwatered the river to the bridge. This dam should be monitored for integrity. If the beaver dam blows out, it could cause a natural, but large shift in the geomorphic condition downstream, potential bank scour and erosion in Reach 2a and 2b and/or temporary flooding.

Photo 31. Numerous beaver dams, like this 4-foot tall dam, are scattered throughout Reach 3, creating impoundments and pools.

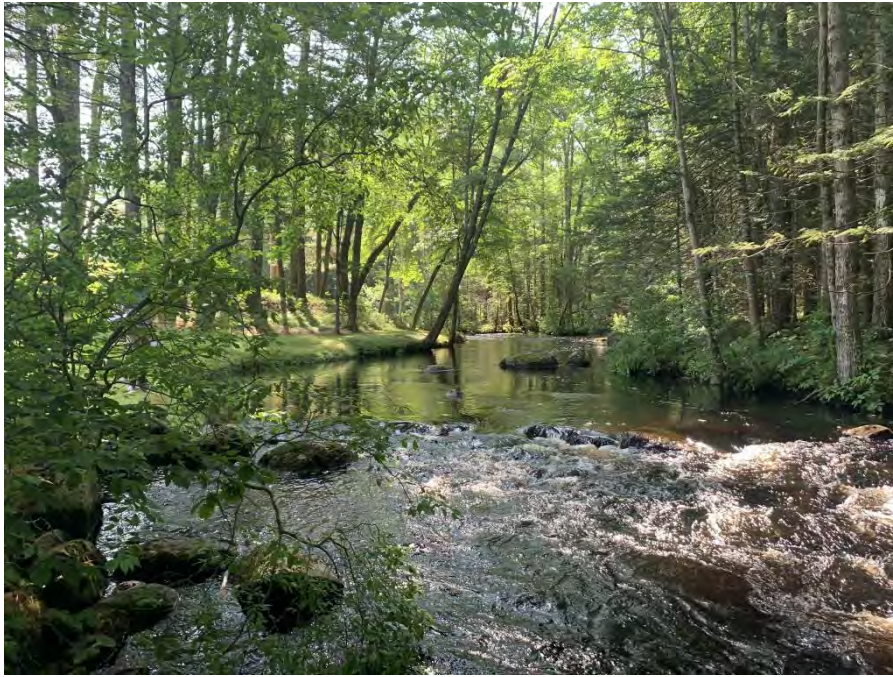
Photo 43. An open field/lawn is mowed to the river's edge within Reach 5.

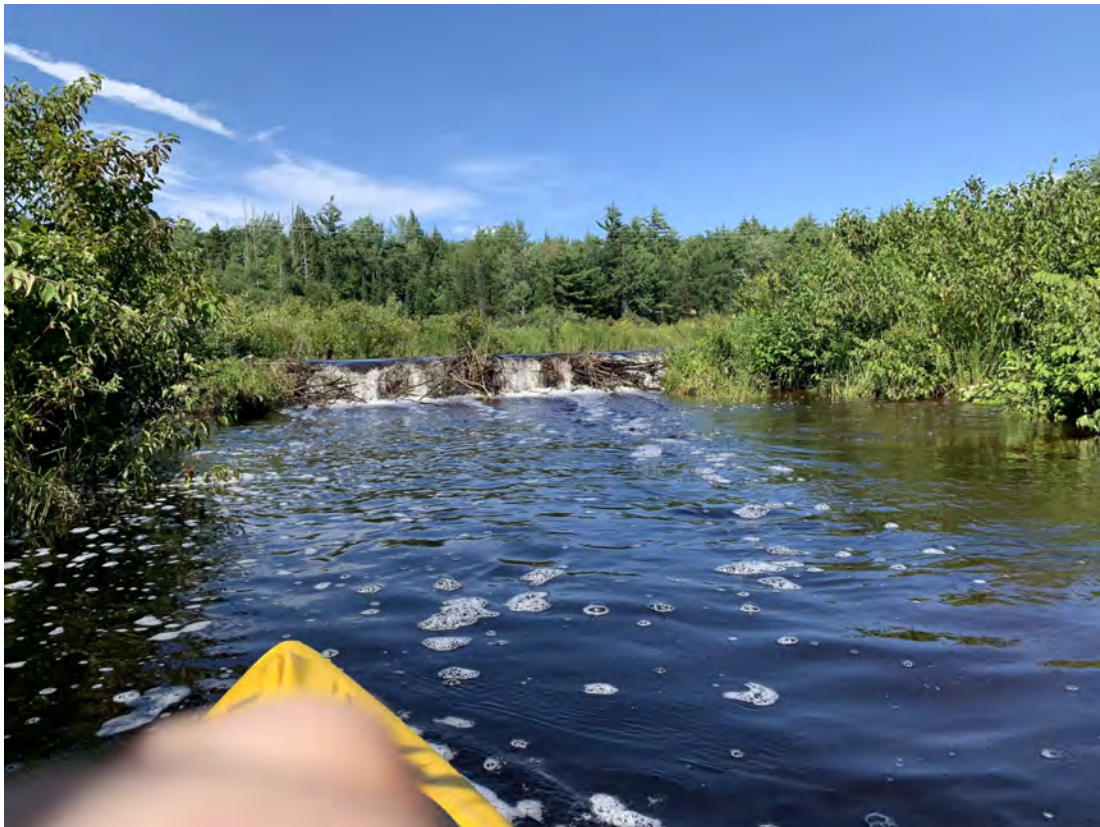
**Photograph 8:** Beaver dam controlling water levels of much of Melvin 4 downstream of New Road

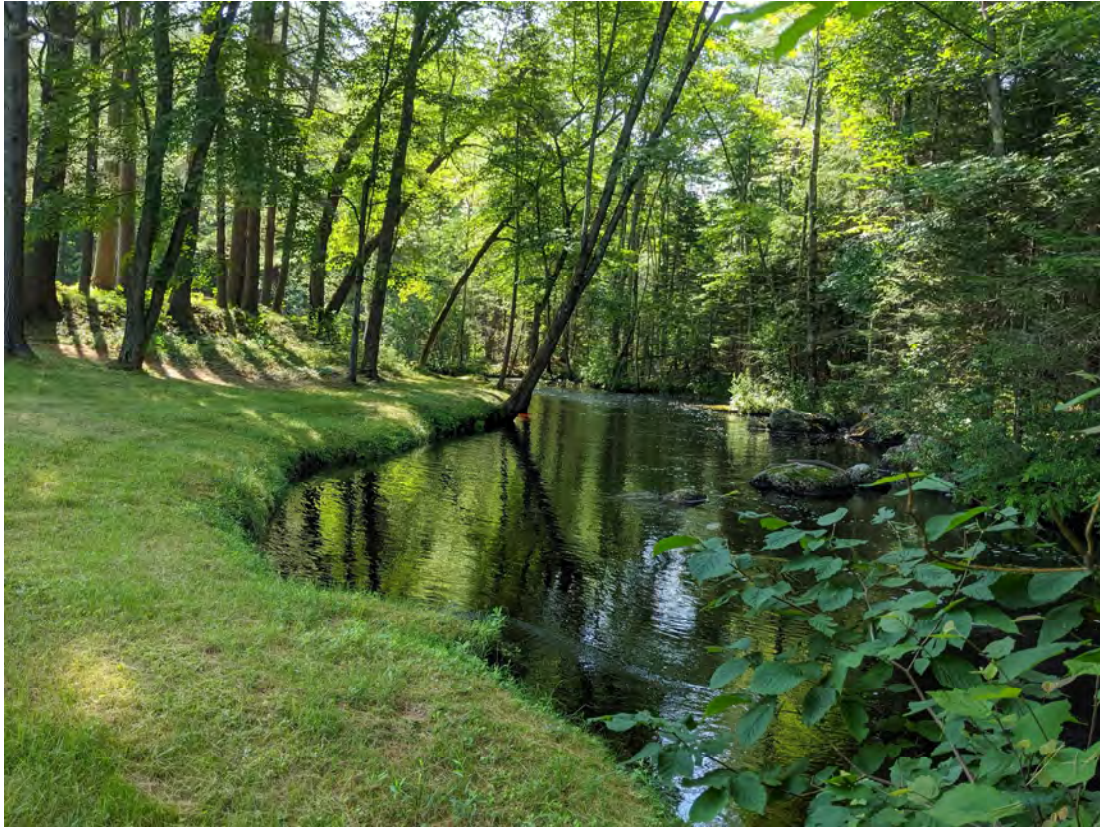
**Photograph 15:** Modified section of Melvin 5 and mowed lawn, upstream of Sodom Road

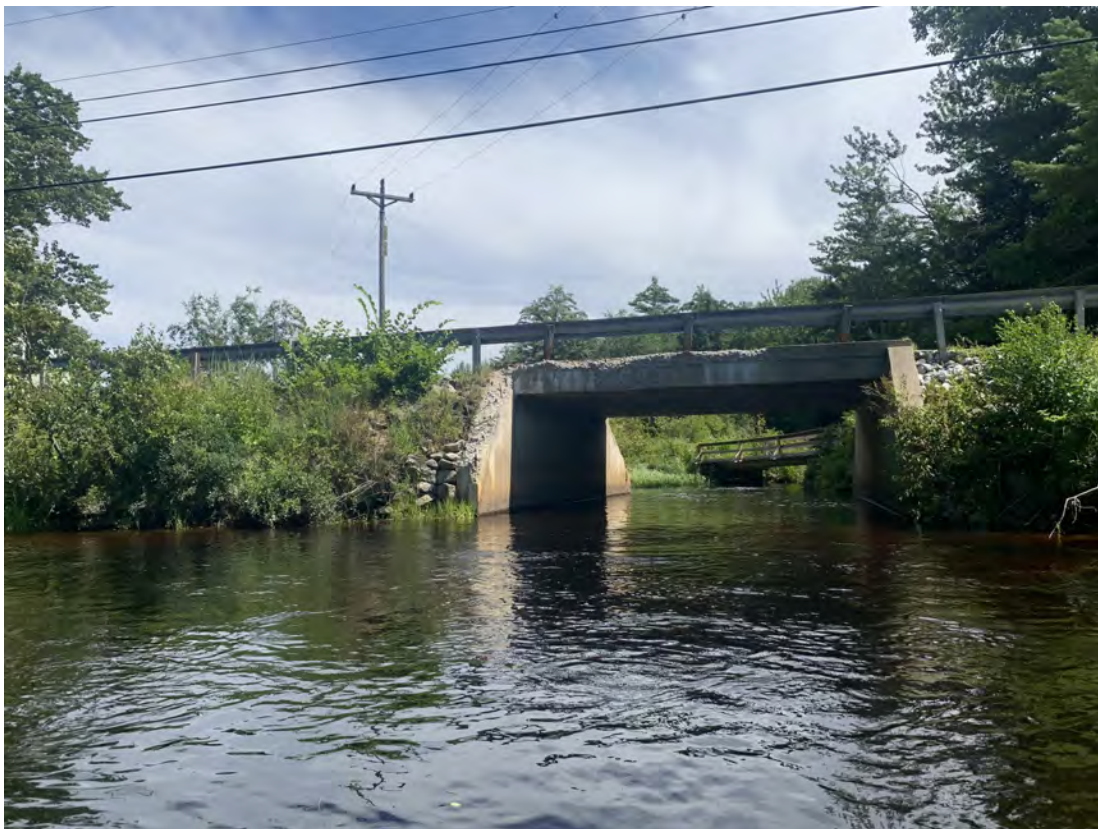
**Photograph 20:** New Road crossing of Melvin River, note erosion on left side (right bank)

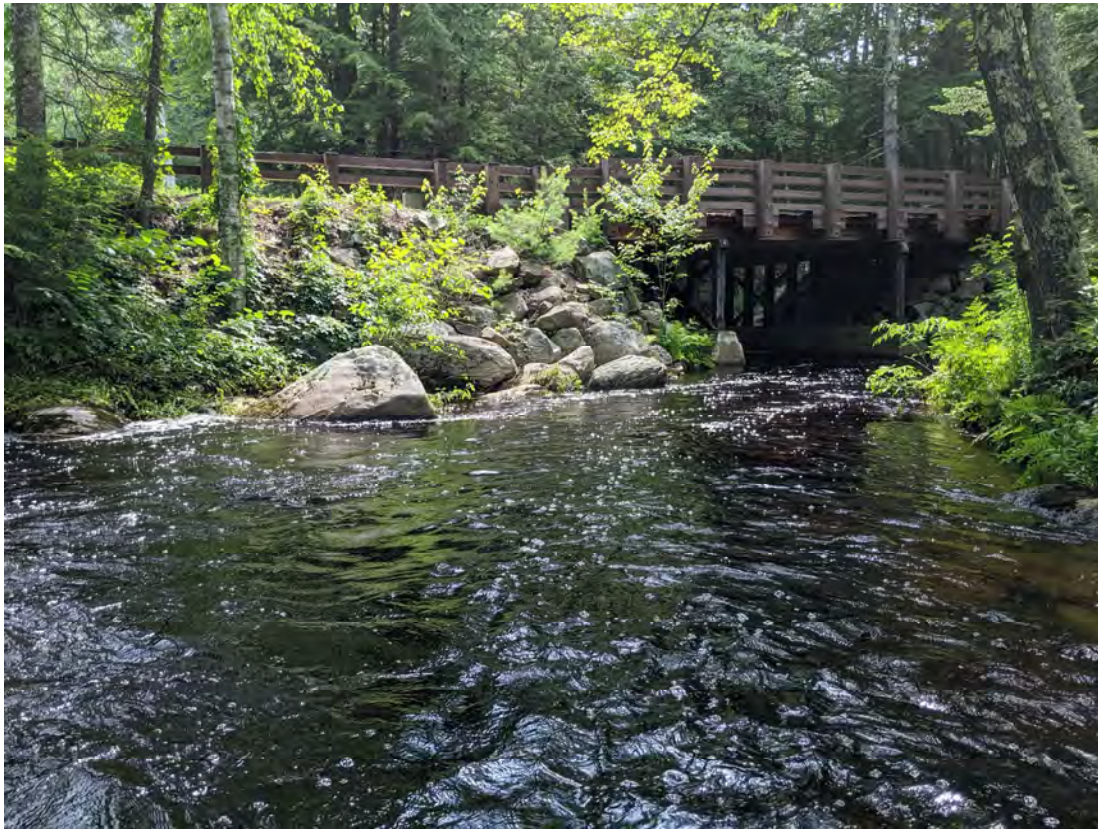
**Photograph 23:** County Road crossing of Melvin River, note poor alignment with river

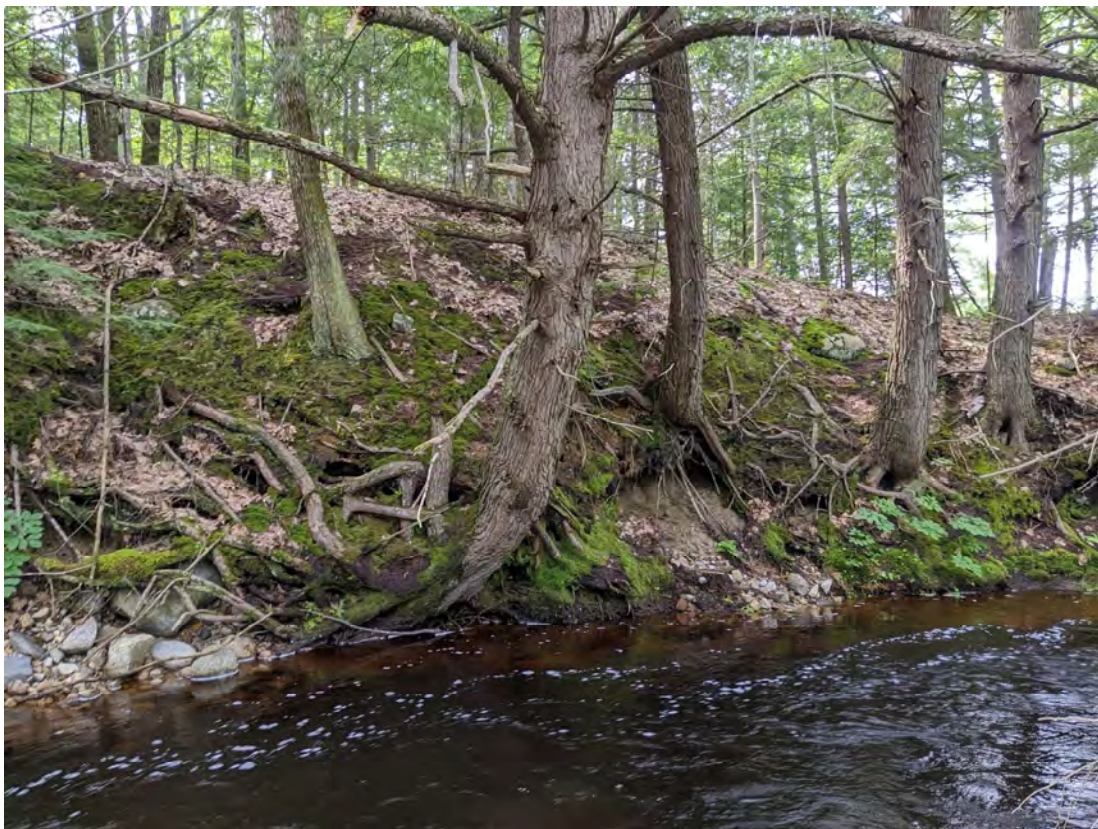
**Photograph 24:** Undercut streambanks stabilized by hemlocks downstream of County Road
