# MELVIN RIVER ASSESSMENT | REPORT

**TO:** Pat Tarpey and Bree Rossiter, Lake Winnepesaukee Association  
**FROM:** Sarah Large, FB Environmental Associates (FBE)  
**SUBJECT:** [Melvin River Assessment](#)  
**DATE:** January 19, 2024; revised March 15, 2024  
**CC:** Forrest Bell and Maggie Mills, FB Environmental Associates (FBE), James Woitdt, Streamworks PPLC

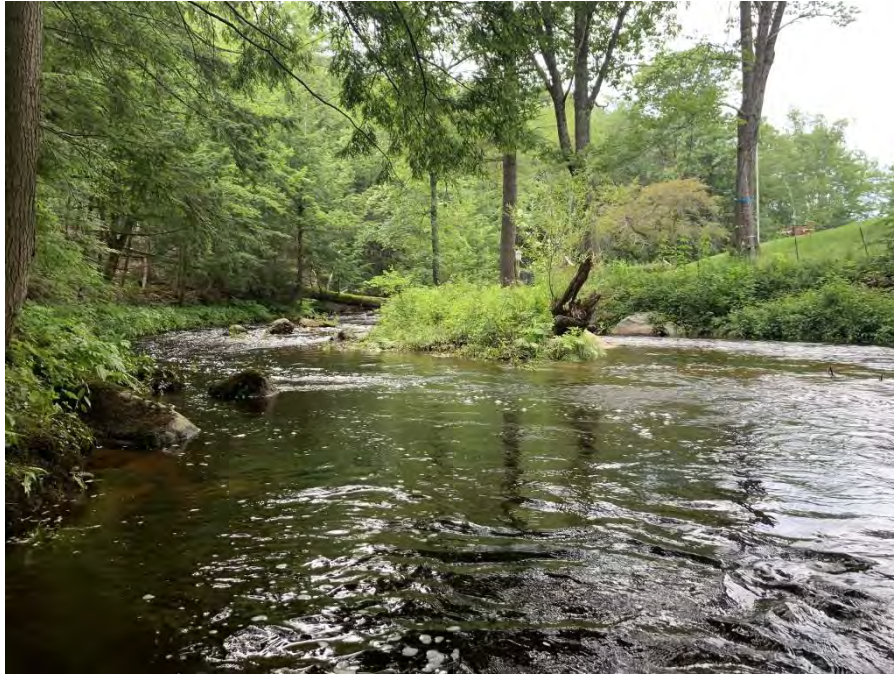
Photo 1. A representative image of a section of Reach 1 downstream of the County Road bridge crossing.

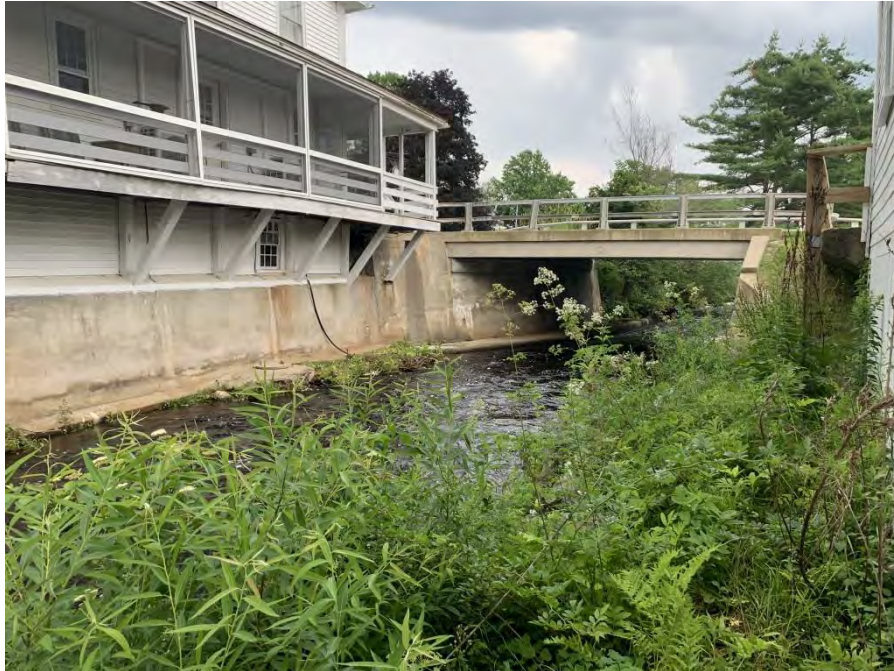
Photo 3. The Melvin River and NH Route 109 bridge are immediately abutted by residential and commercial development.

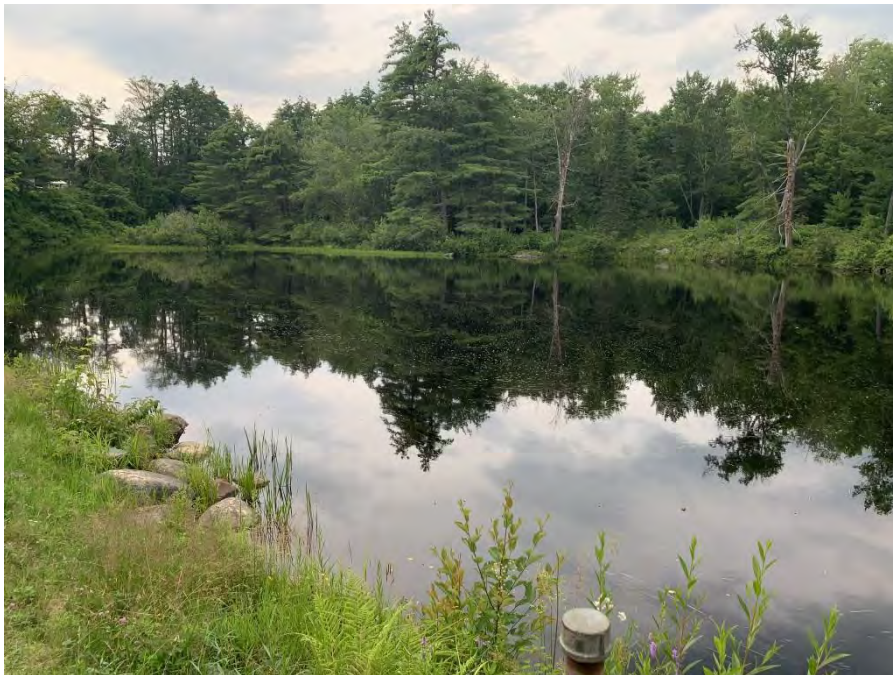
Photo 6. The Pope Dam impounds and widens the Melvin River's channel.

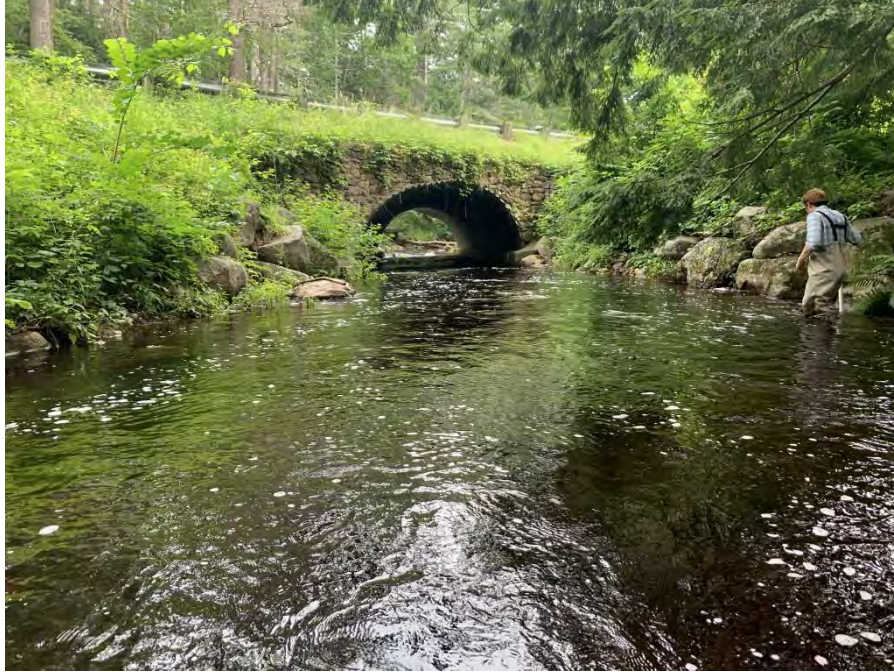
Photo 7. The inlet and out of the High Street culvert crossing are armored with riprap.

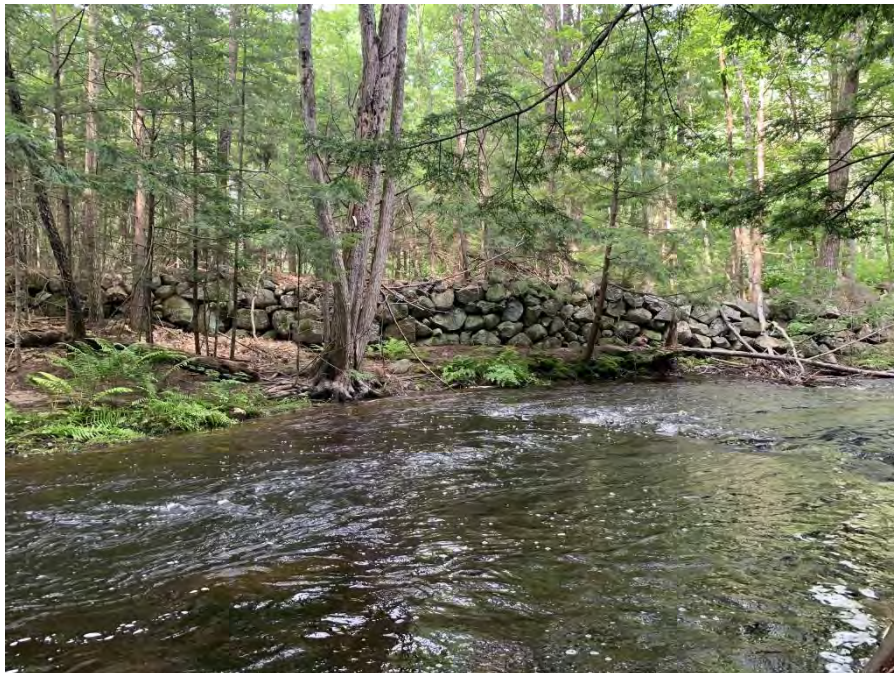
Photo 8. Dry-stacked boulder wall running parallel to the river upstream of the High Street Crossing.

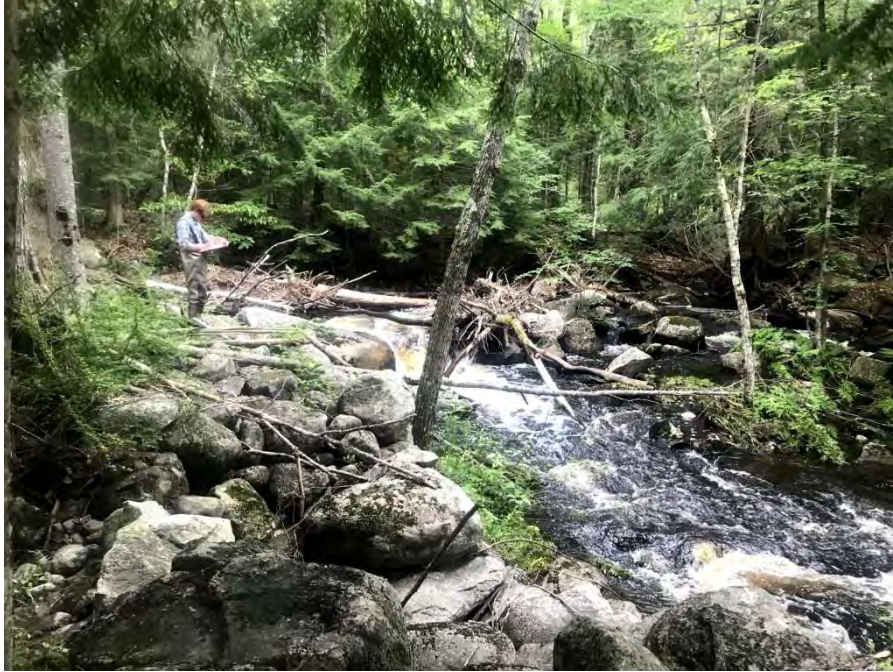
Photo 9. Remnants of a dam (Dam #1 Ruins) extend across Reach 1's channel.

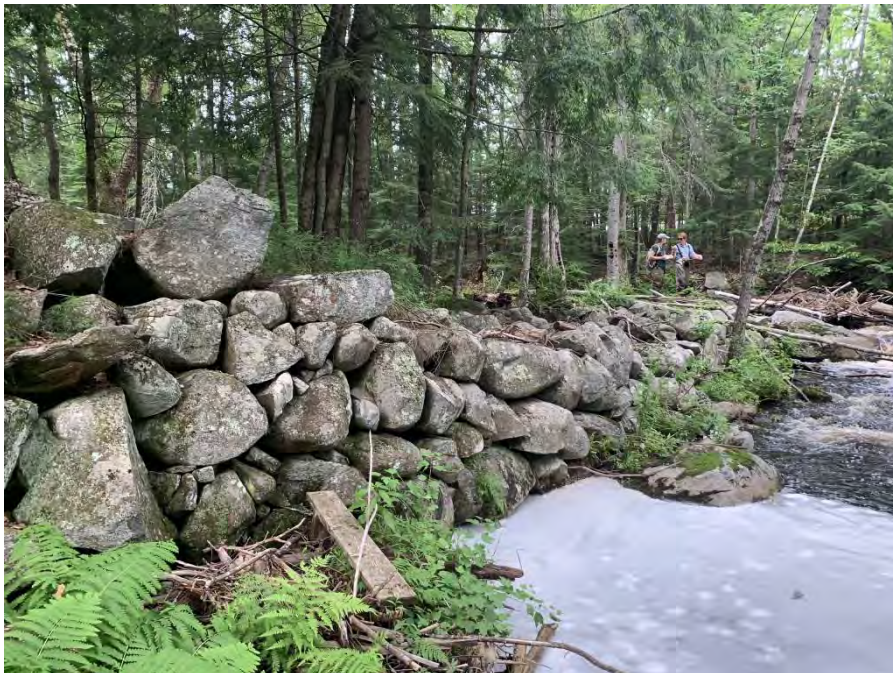
Photo 10. The Dam #1 Ruins were comprised of large and medium boulders stacked perpendicular across the river.

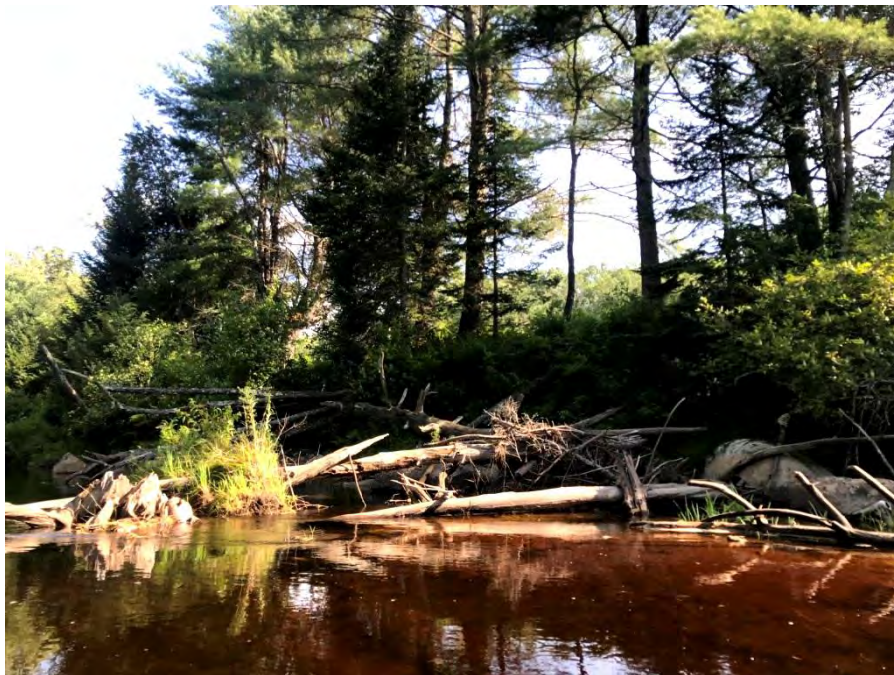
Photo 16. Suitable in-stream aquatic organism habitat, woody material and log jams, are present throughout Reaches 2a and 2b.

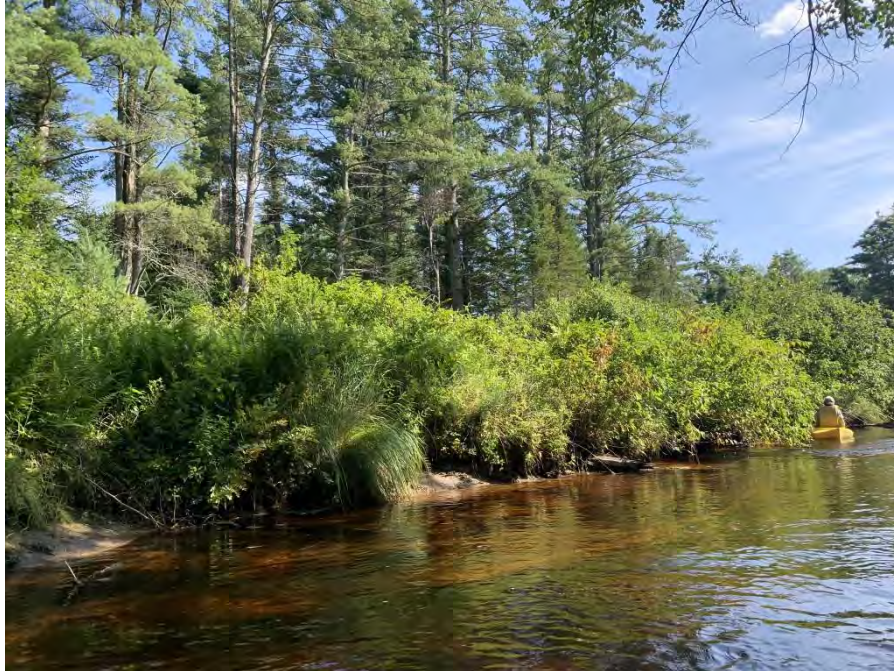
Photo 17. Logging activity, a thinned forest adjacent to Reach 2a and 2b, was noticeable from the channel.

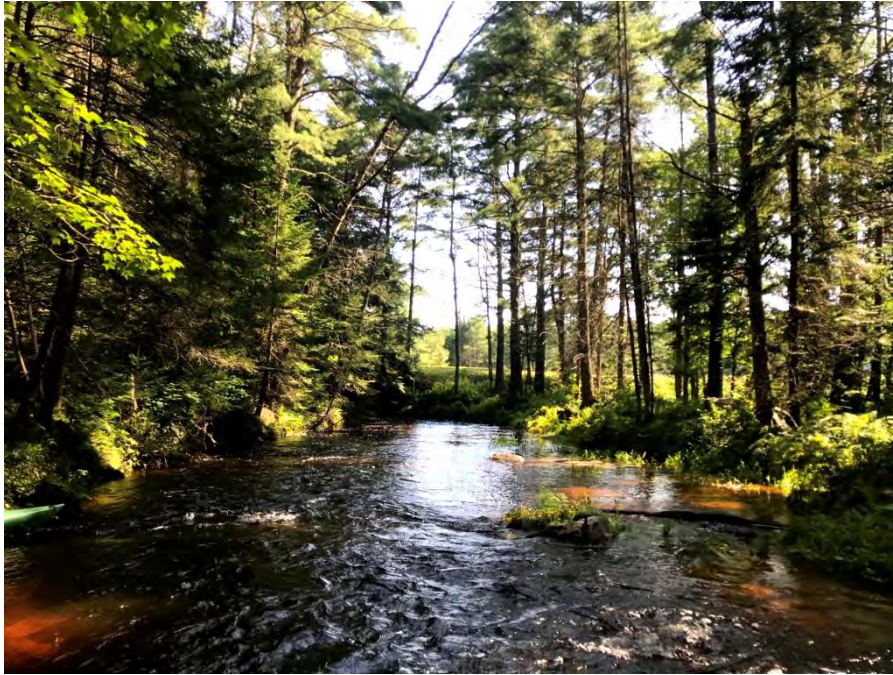
Photo 19. Reach 2b's riparian corridor transitions from predominantly forested to a thin forest buffer along the edge of a field.

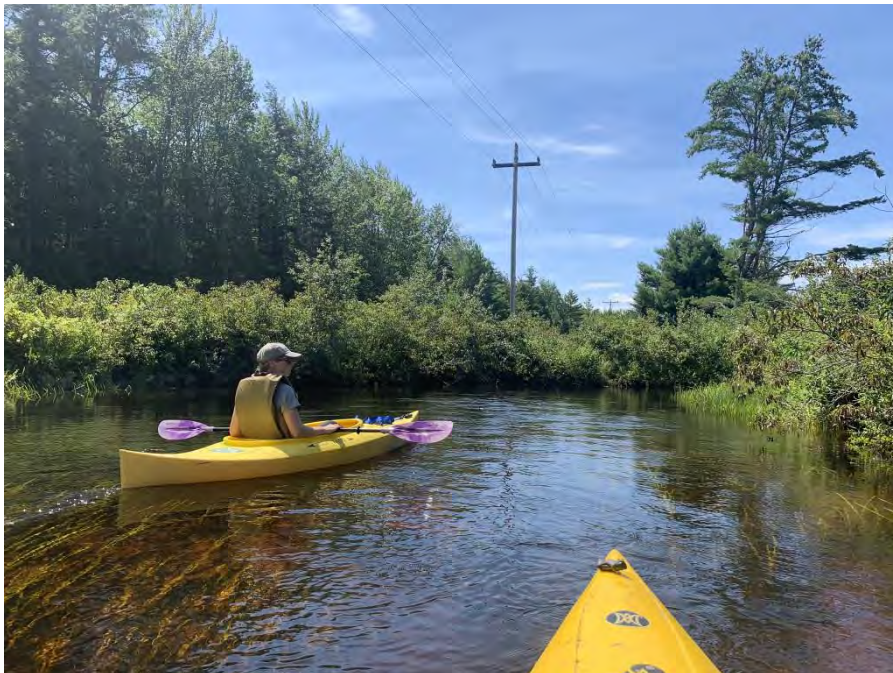
Photo 22. A utility corridor runs along the lower half of Reach 3.

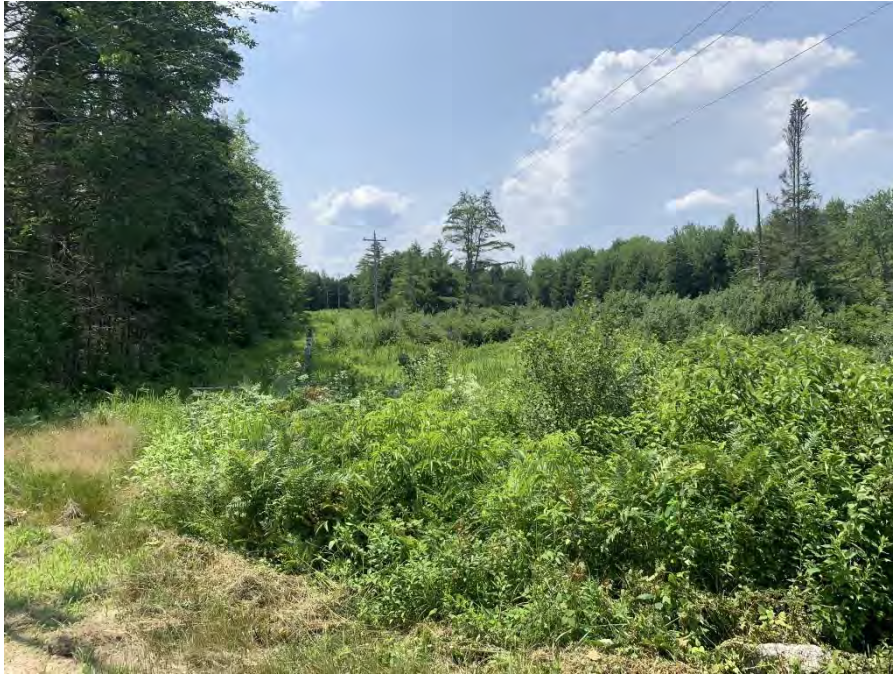
Photo 25. The utility corridor, accessible from New Road, is comprised of a mix of scrub-shrub vegetation.

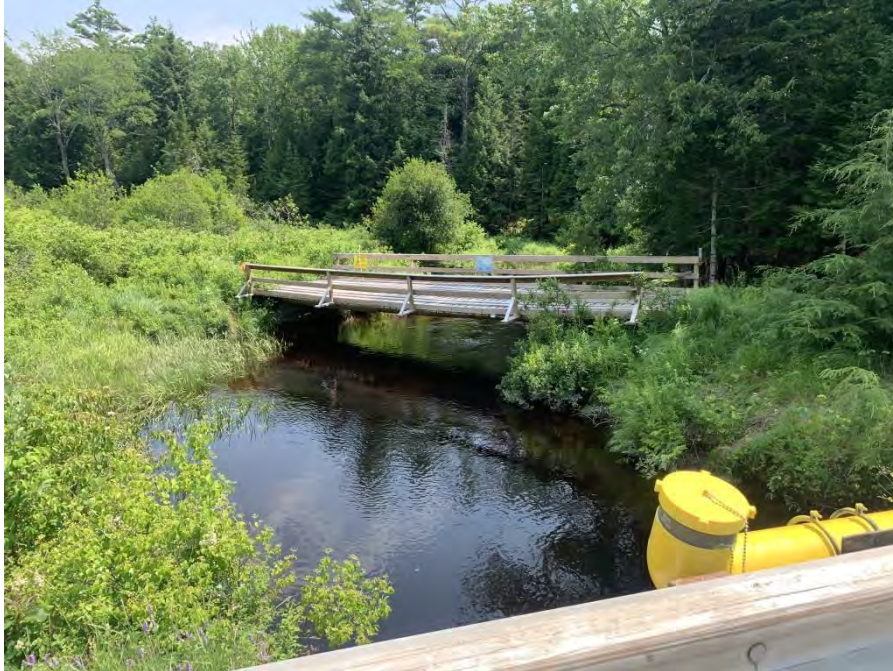
Photo 27. Immediately upstream of the New Road crossing is another Snowmobile Trail crossing (#2) spanning across Reach 3.

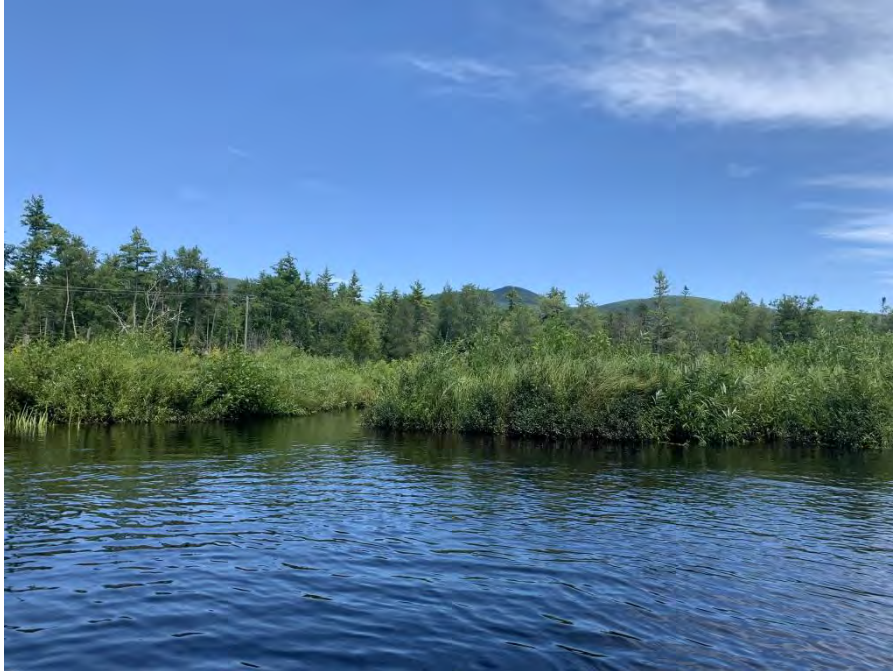
Photo 29. The wetland complex surrounding Reach 3 is a diverse and robust ecosystem supporting aquatic and terrestrial wildlife.

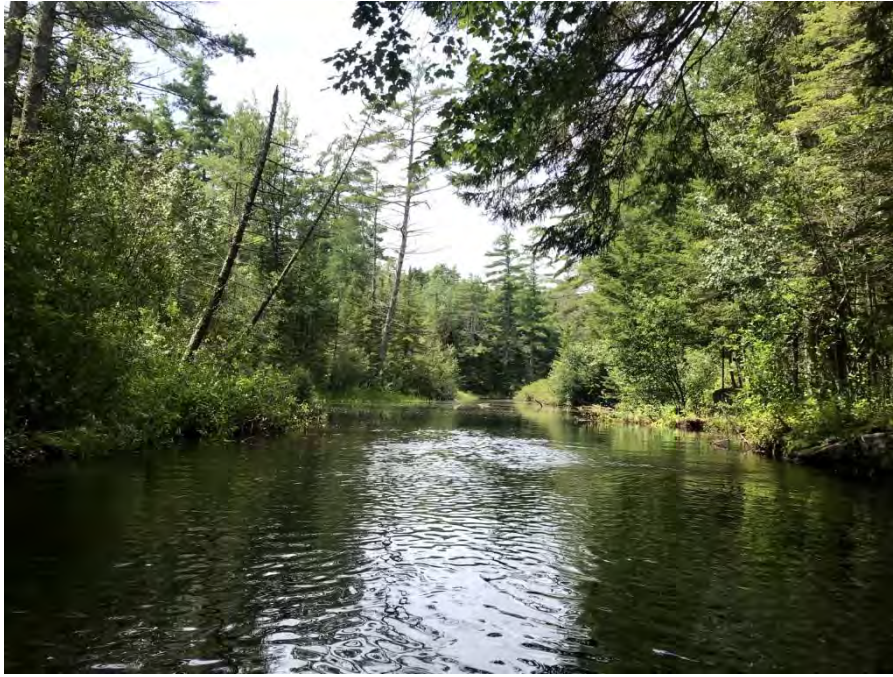
Photo 33. The study reach transitions back to a forested and scrub-shrub riparian buffer in Reach 4.

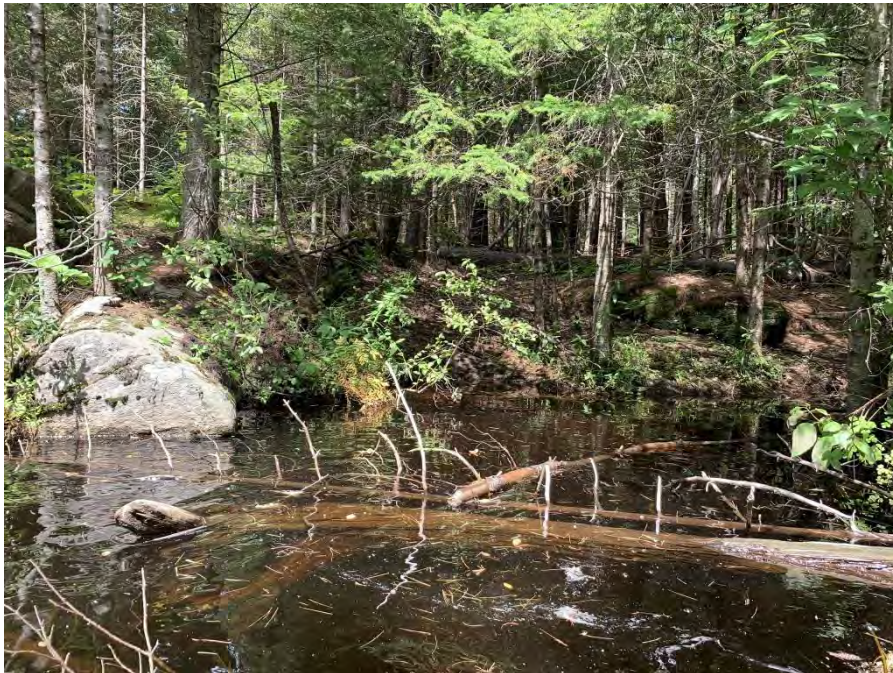
Photo 34. Reach 4 contained an abundant amount of large woody material providing in-stream aquatic organism habitat.

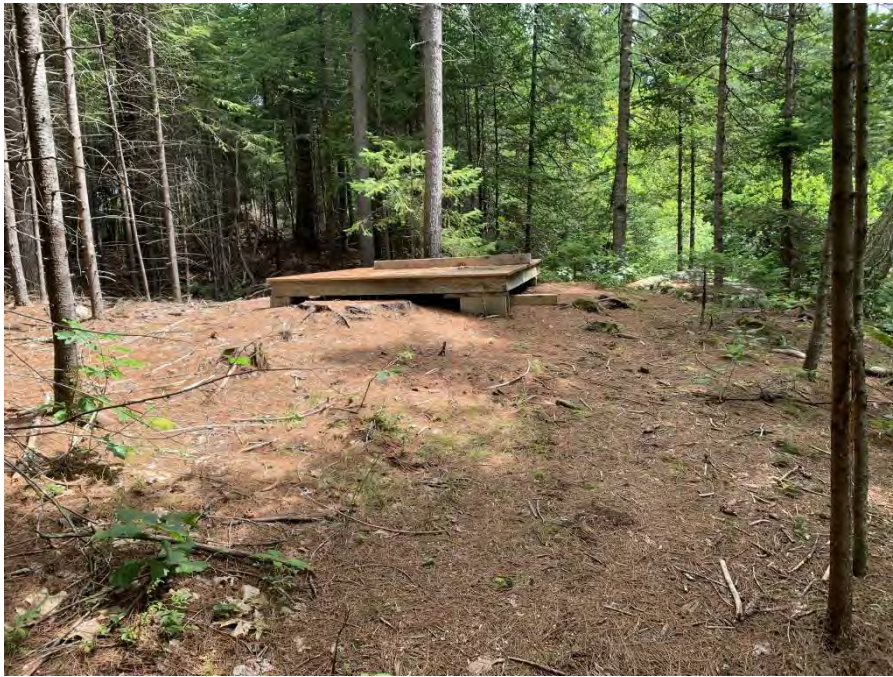
Photo 35. The riparian buffer along Reach 4 is predominately undeveloped, except for a few discrete features associated with residences along Sodom Road, such as the wooden platform depicted above.

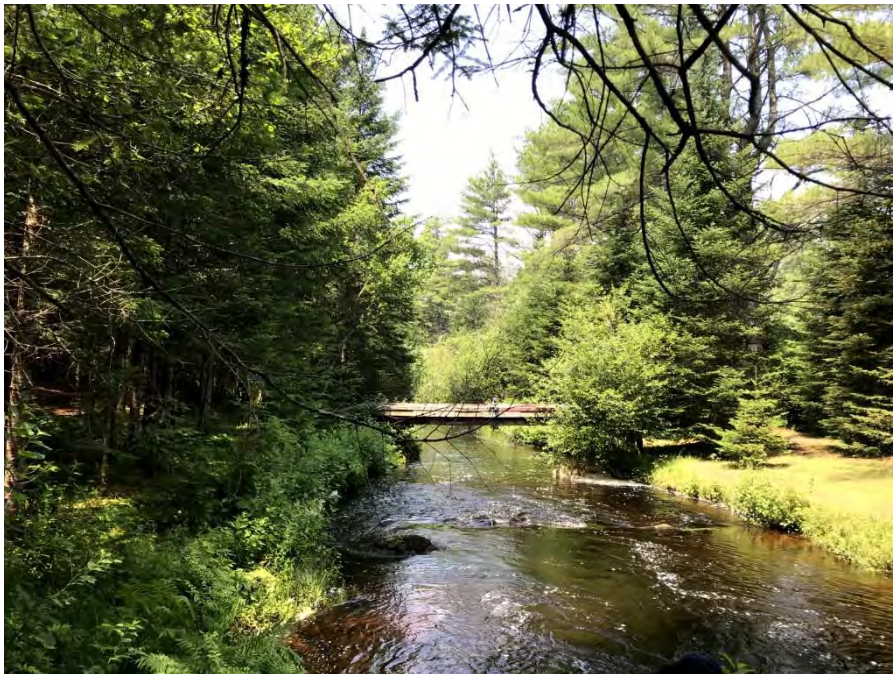
Photo 36. A resident along Sodom Road constructed a private trail bridge spanning the banks of Reach 4 linking their backyard to a forested trail on the other side.

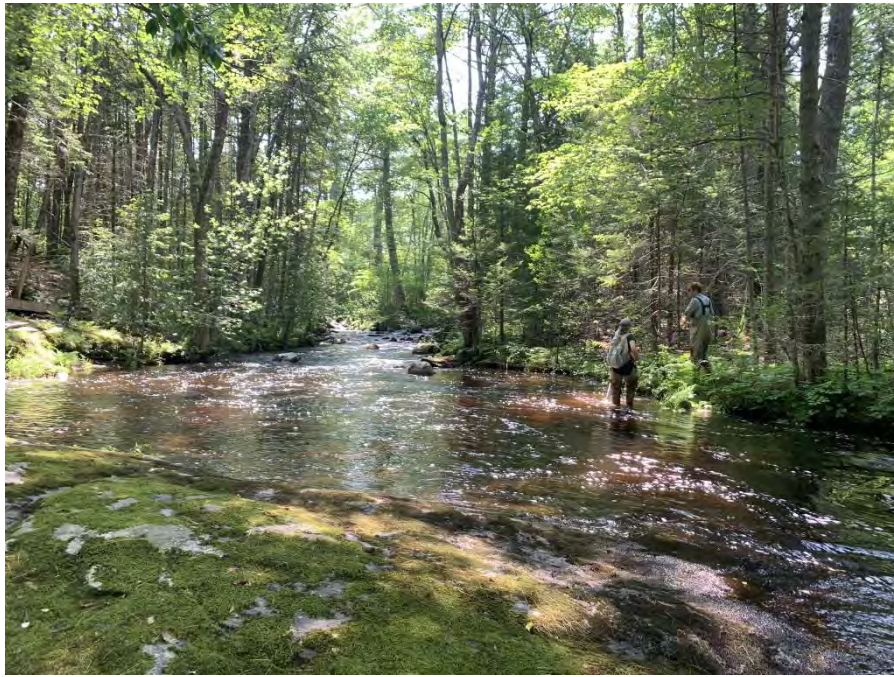
Photo 37. Reach 5 exhibited a geomorphic shift in substrate and slope, featuring bedrock outcrops and a steeper gradient.

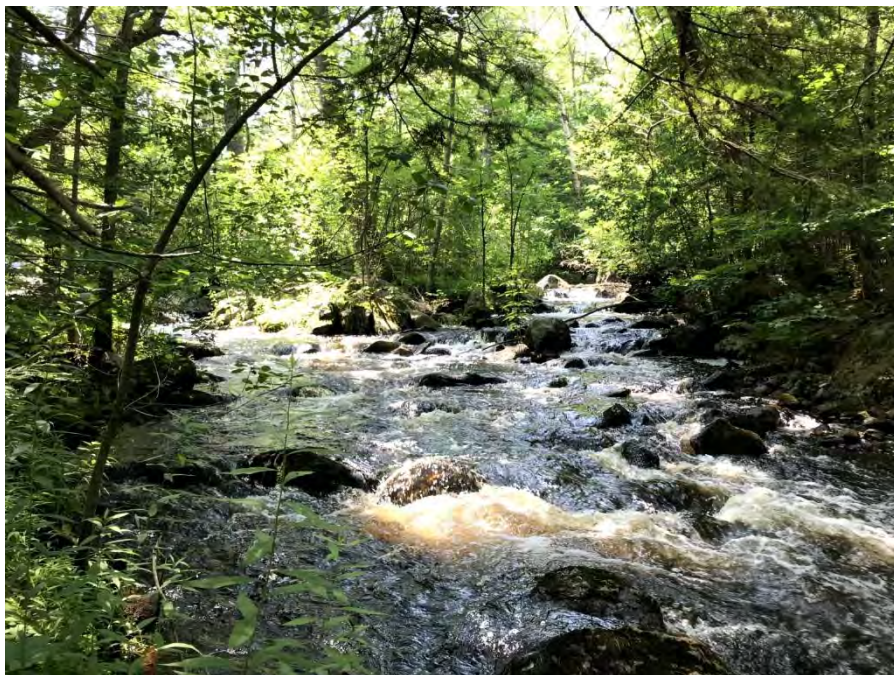
Photo 38. Another notable characteristic of Reach 5 is the stream channel's shift in morphology, showcasing an area of bifurcation.

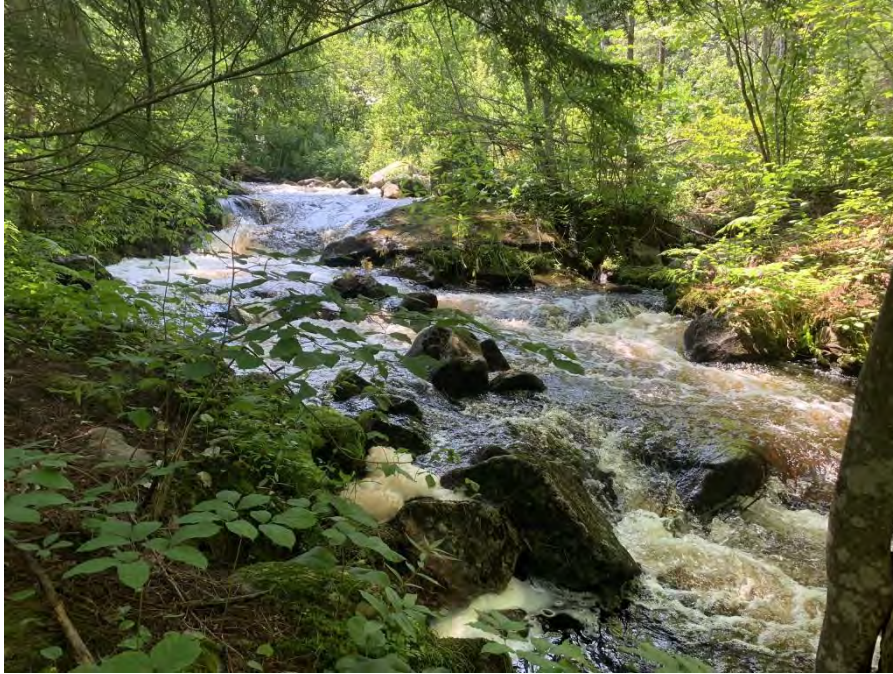
Photo 39. At the bifurcation, one branch of Reach 5's channel flows down a bedrock sluice.

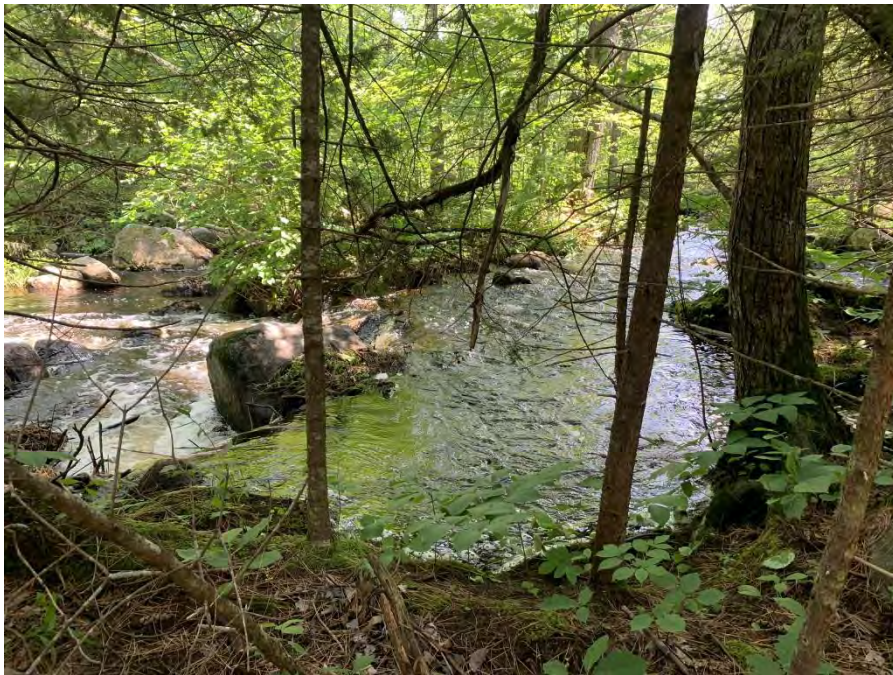
Photo 40. Along the other branch of Reach 5, the channel cascades/waterfalls over boulders.

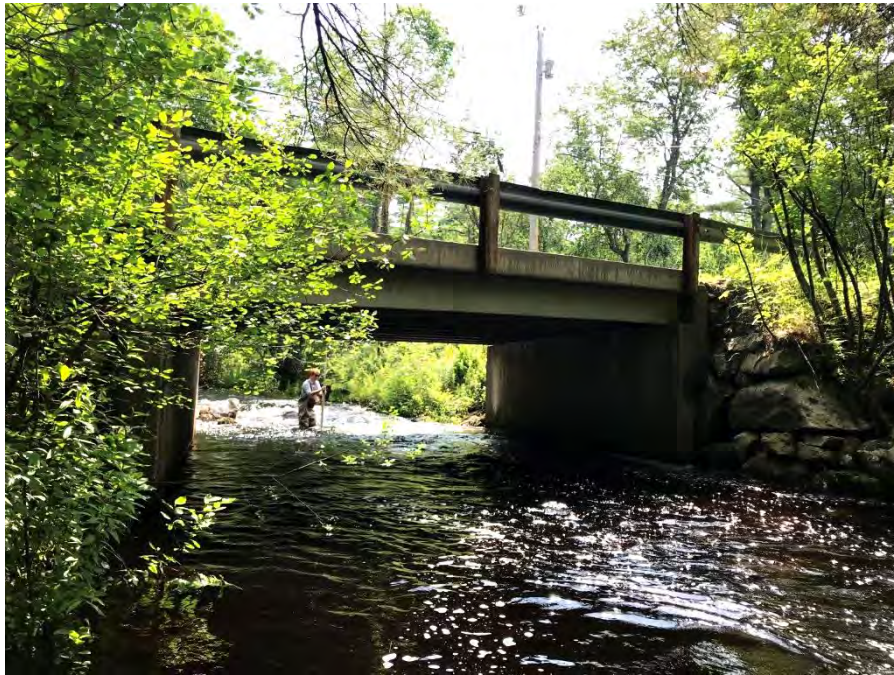
Photo 41. An open-bottom bridge conveys flow of Reach 5 under Sodom Road.

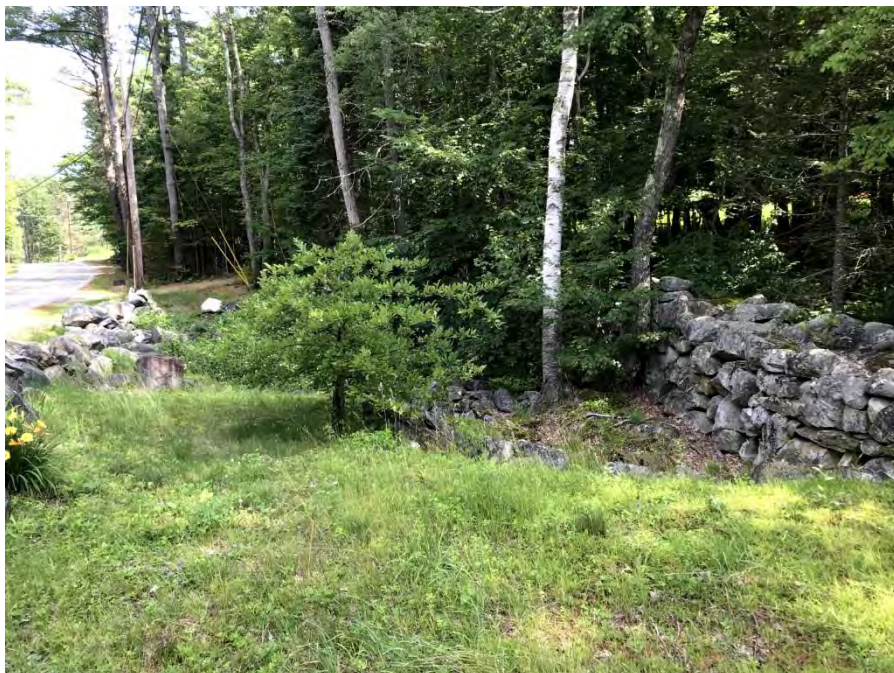
Photo 42. Remnants of dam structures, identified as Dam #2 Ruins, were found adjacent to (upstream and downstream) Reach 5.

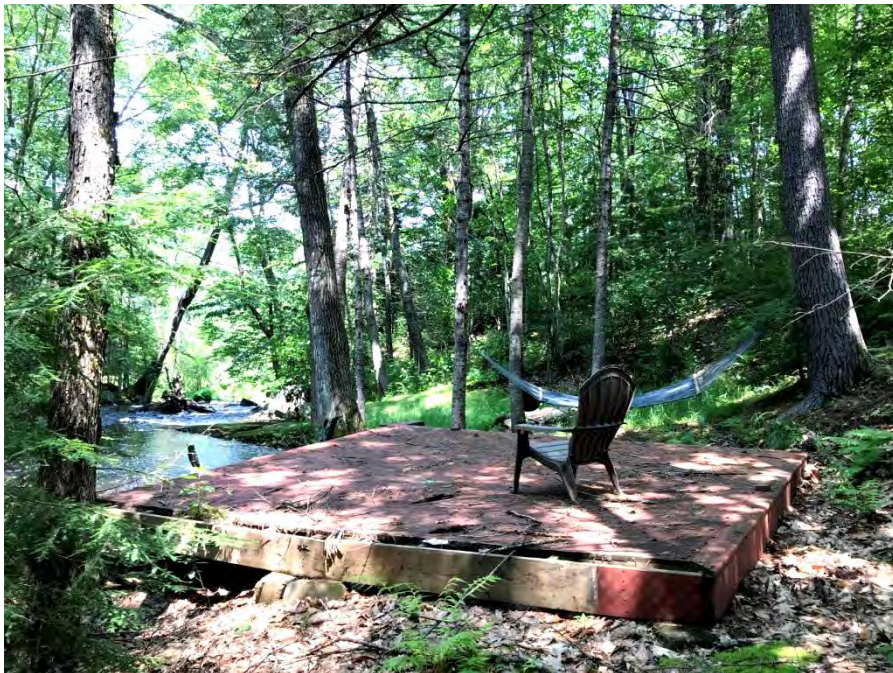
Photo 44. In the lower half of Reach 5, a resident along Sodom Road built a riverside wooden platform.

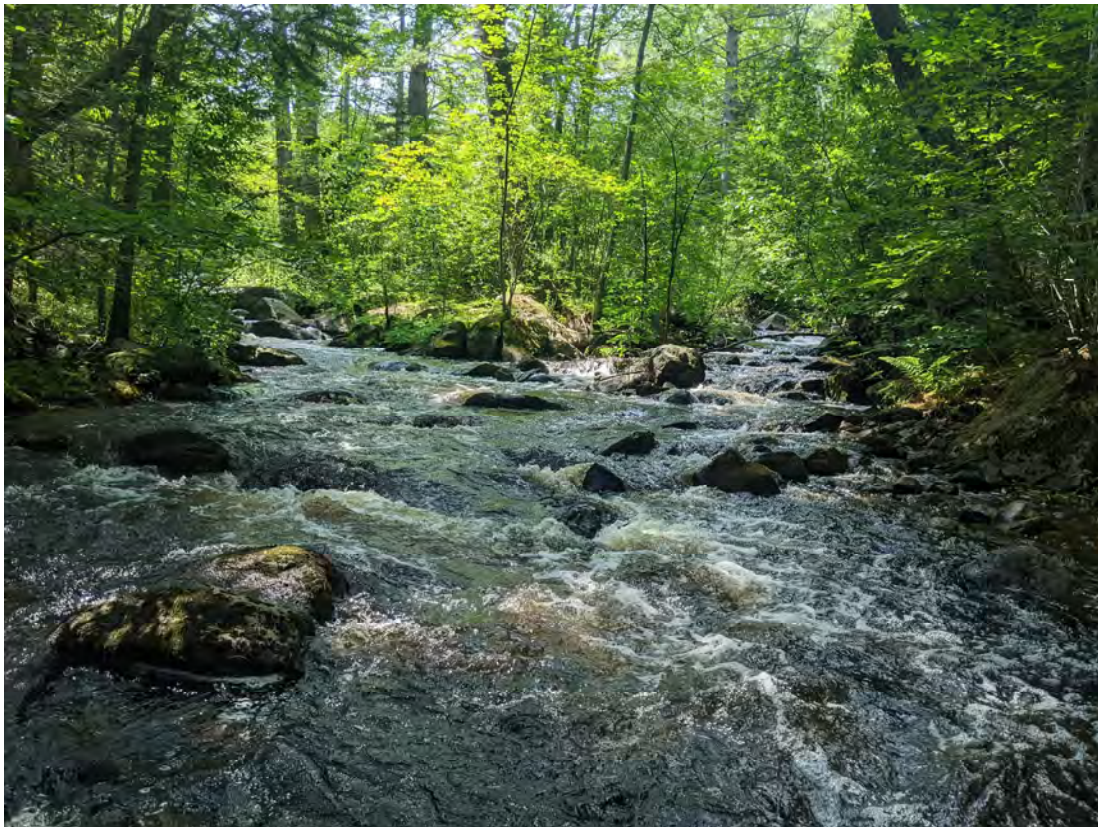
**Photograph 2:** Downstream end of bifurcation / realignment below Sodom Road

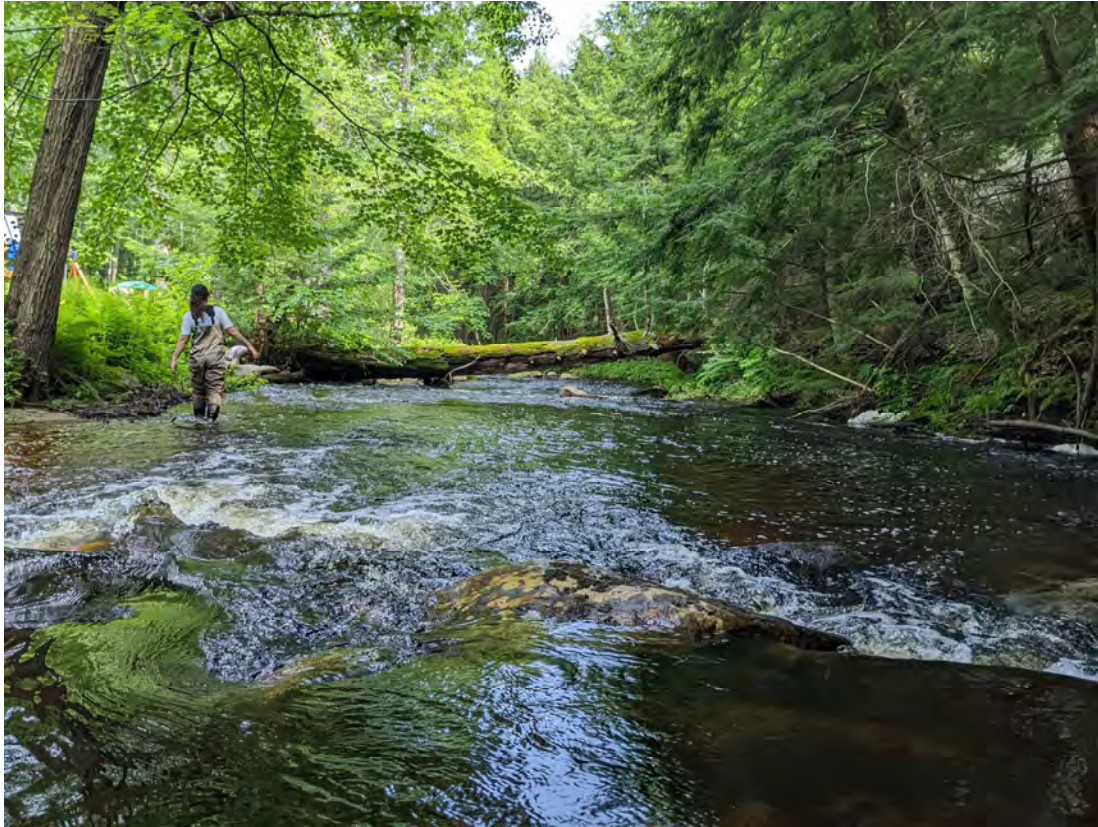
**Photograph 13:** Representative photograph of Melvin 1a, upstream of Melvin River Dam #1

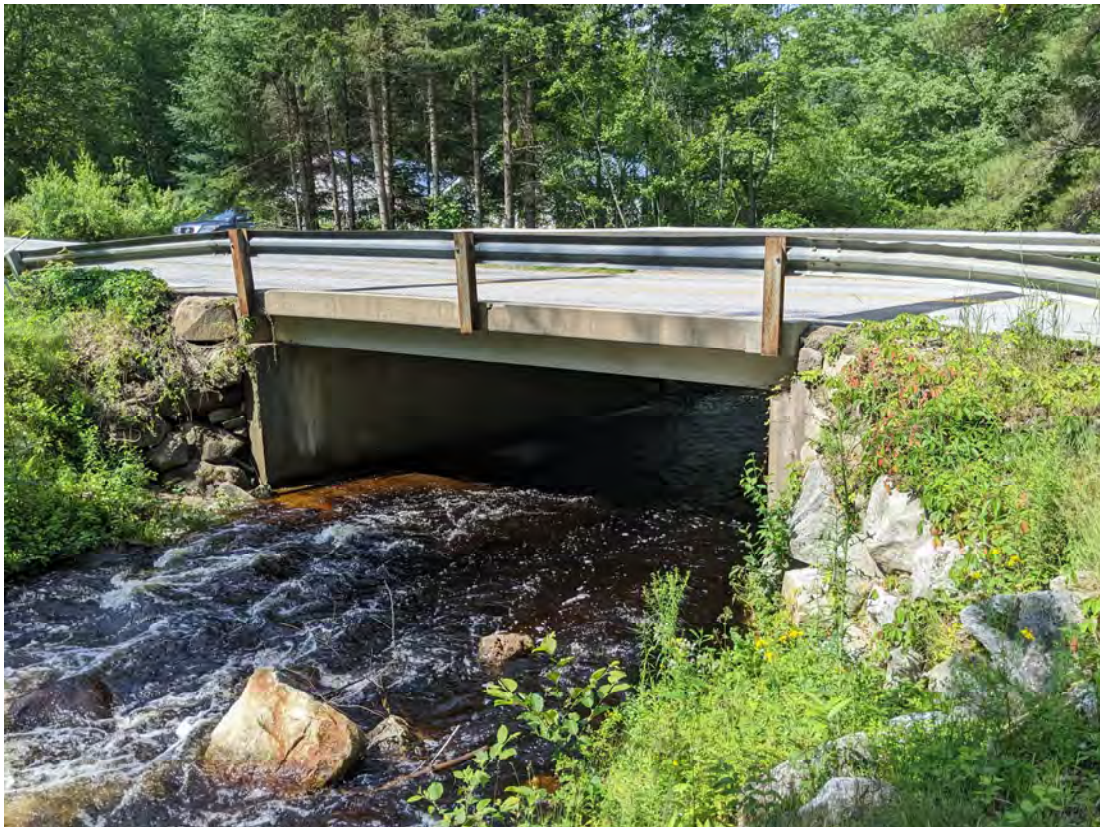
**Photograph 16:** Sodom Road crossing of Melvin River

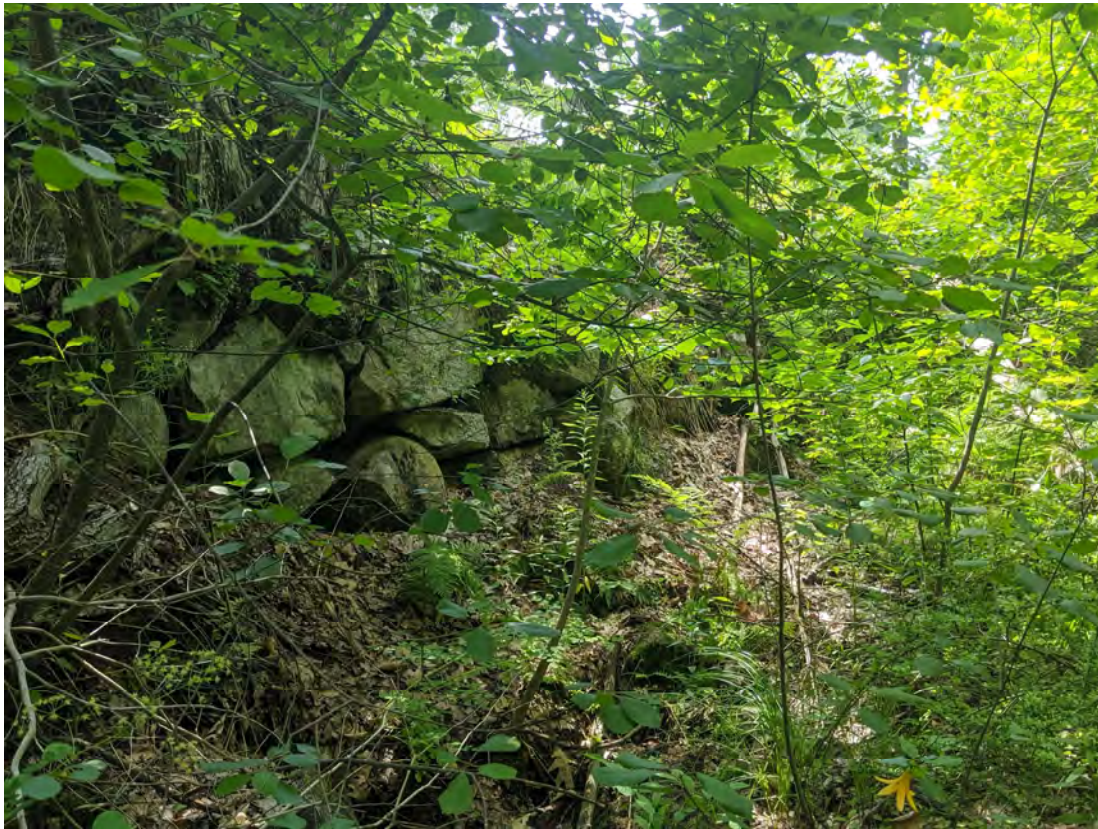
**Photograph 17:** Masonry on downstream slope of Sodom Road, potentially former dam

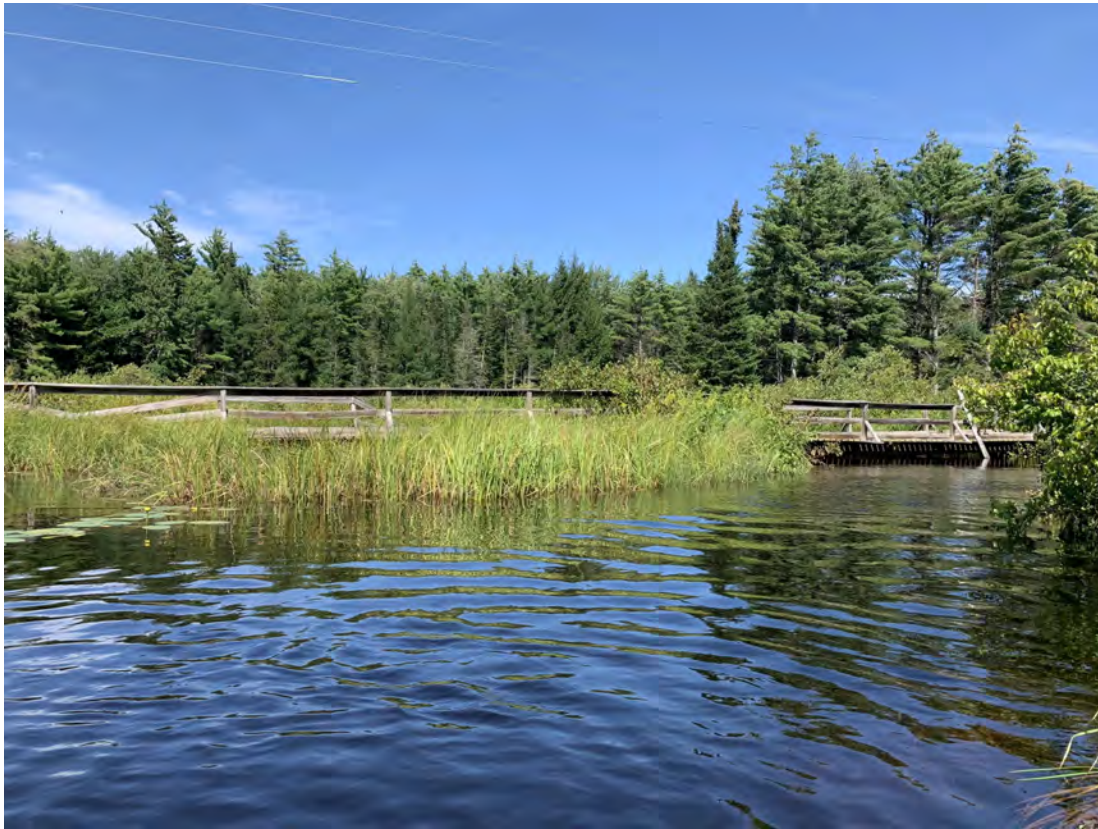
**Photograph 21:** Snowmobile crossing at downstream end of Melvin 3

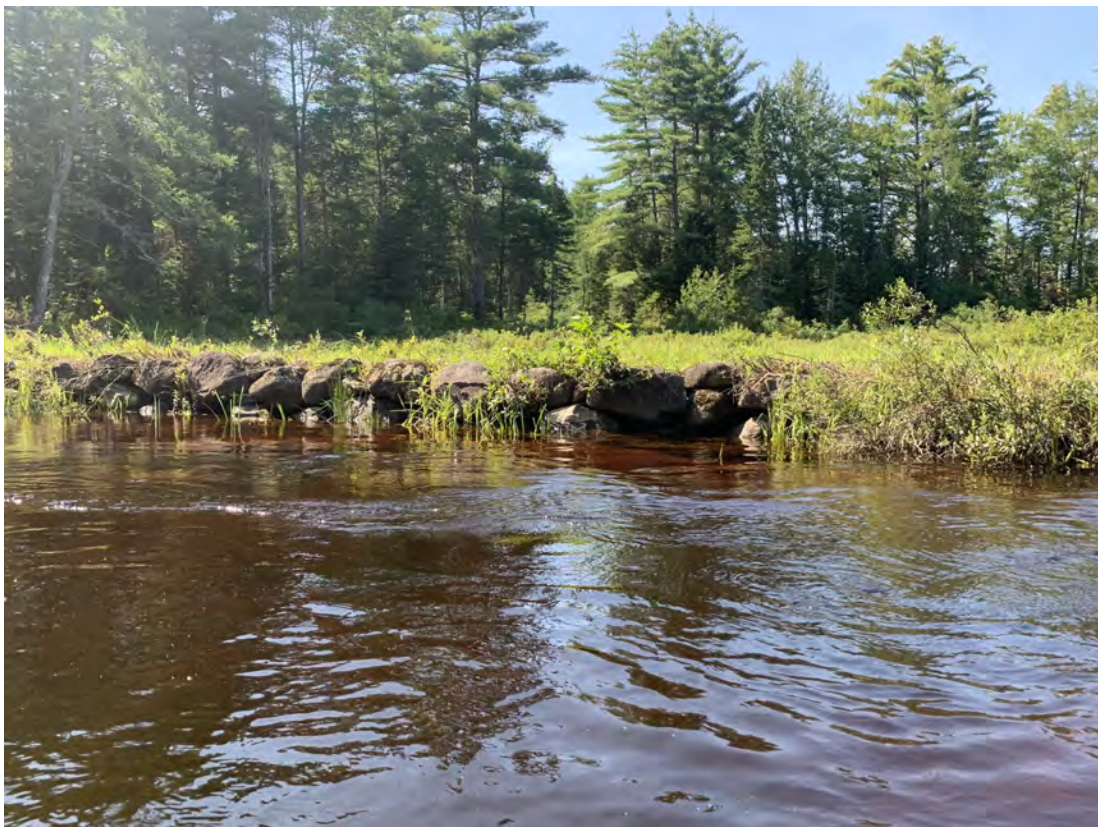
**Photograph 22:** Revetment at downstream end of Melvin 3

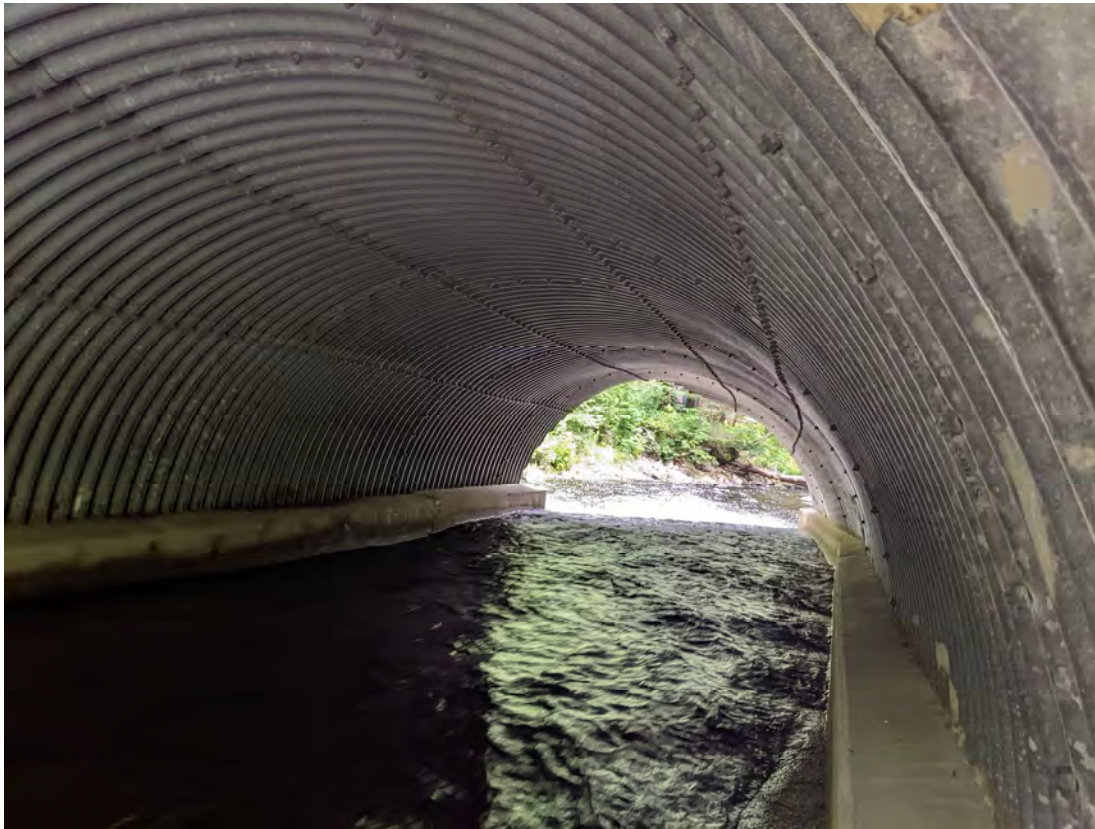
**Photograph 25:** Culvert conveying Melvin River beneath High Street
