# MELVIN RIVER ASSESSMENT | REPORT

**TO:** Pat Tarpey and Bree Rossiter, Lake Winnepesaukee Association  
**FROM:** Sarah Large, FB Environmental Associates (FBE)  
**SUBJECT:** [Melvin River Assessment](#)  
**DATE:** January 19, 2024; revised March 15, 2024  
**CC:** Forrest Bell and Maggie Mills, FB Environmental Associates (FBE), James Woitdt, Streamworks PPLC

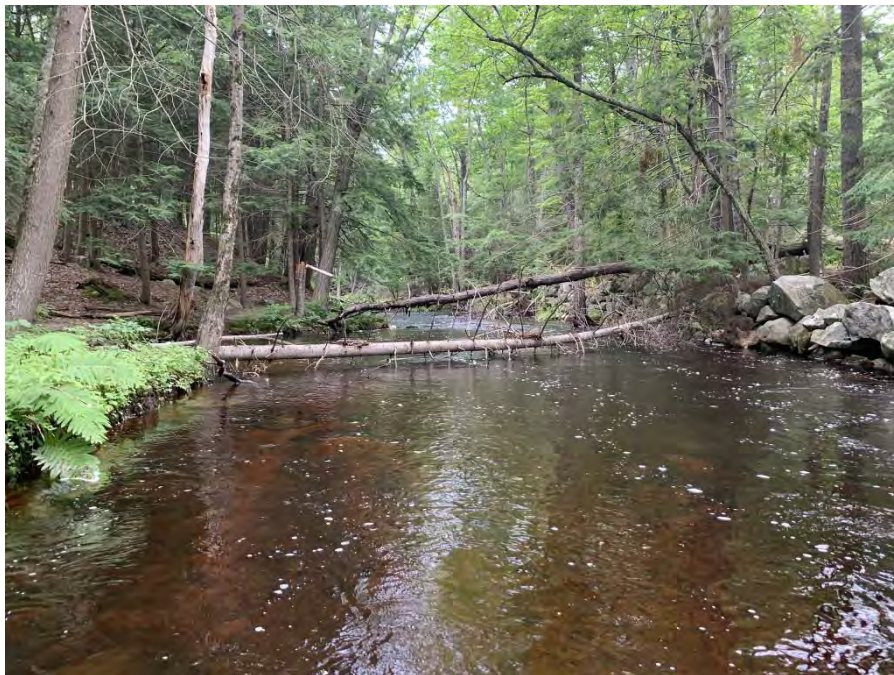
Photo 2. Large woody material and naturally undercut banks were present throughout Reach 1.

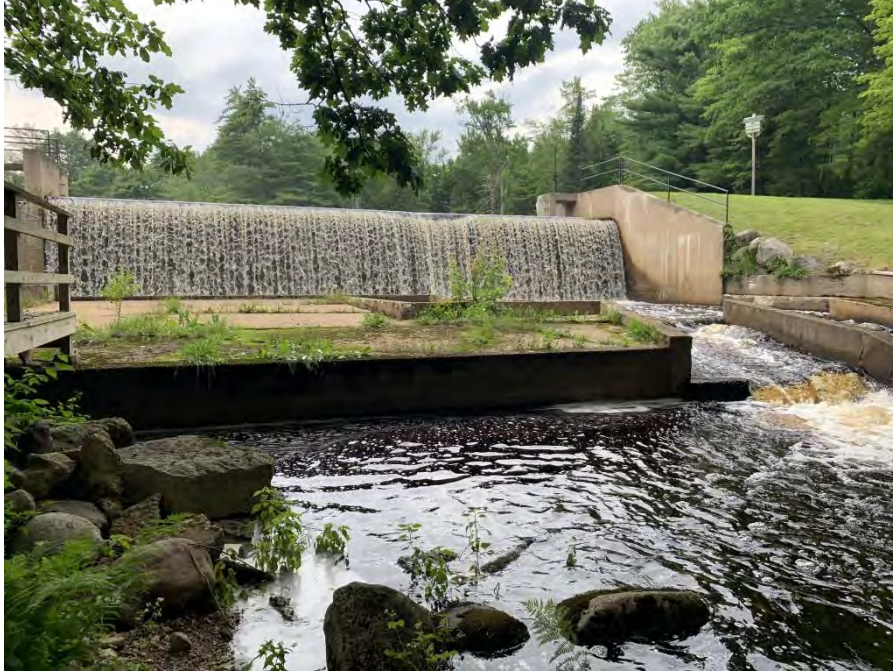
Photo 5. Downstream of the Pope/Melvin River Dam.

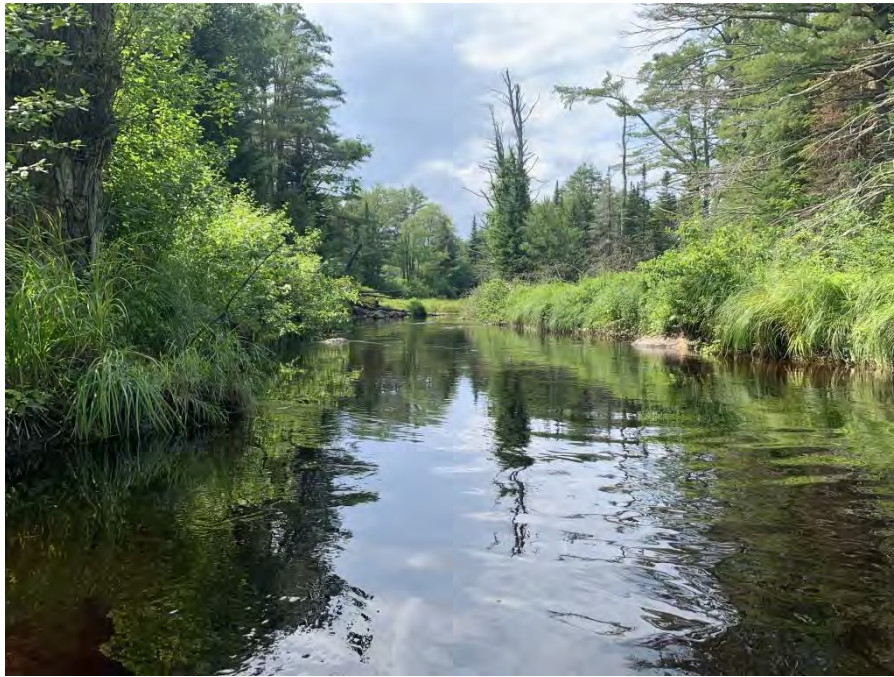
Photo 15. A representative photo of Reach 2a.

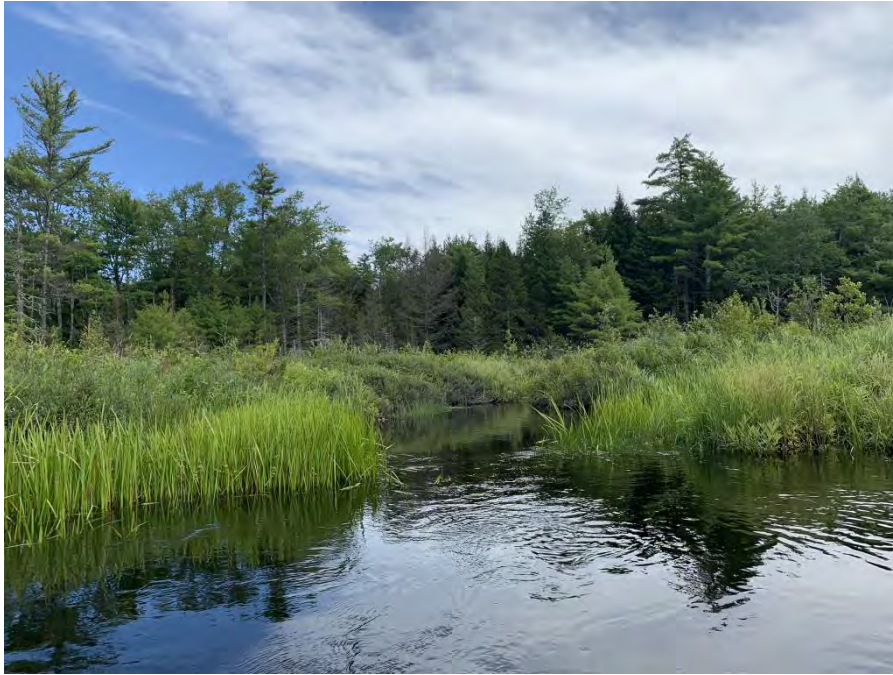
Photo 21. Reach 3 meanders through a very large emergent and scrub-shrub wetland complex.

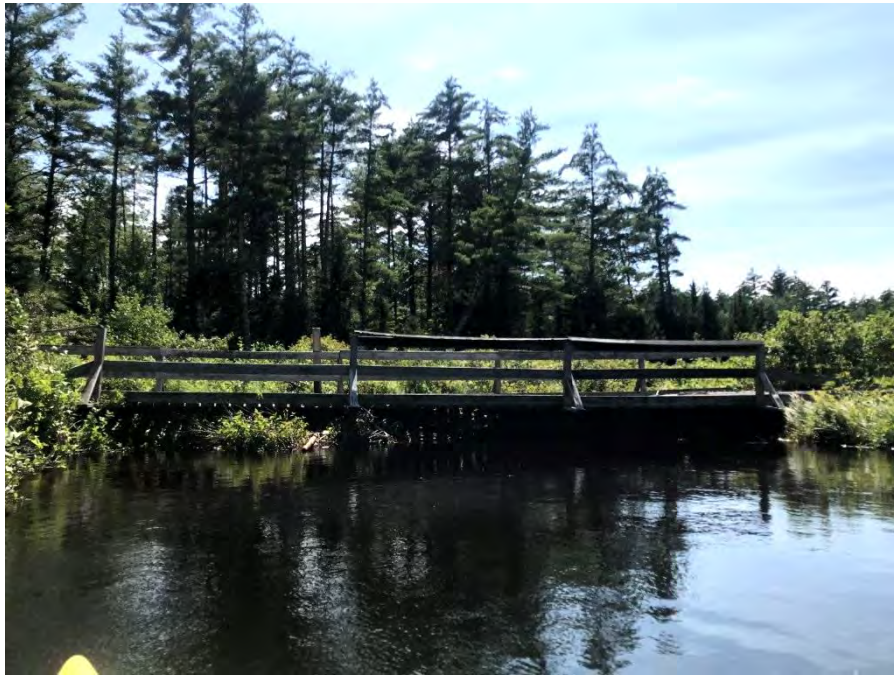
Photo 23. Connected to the utility corridor is Snowmobile Trail #1 crossing.

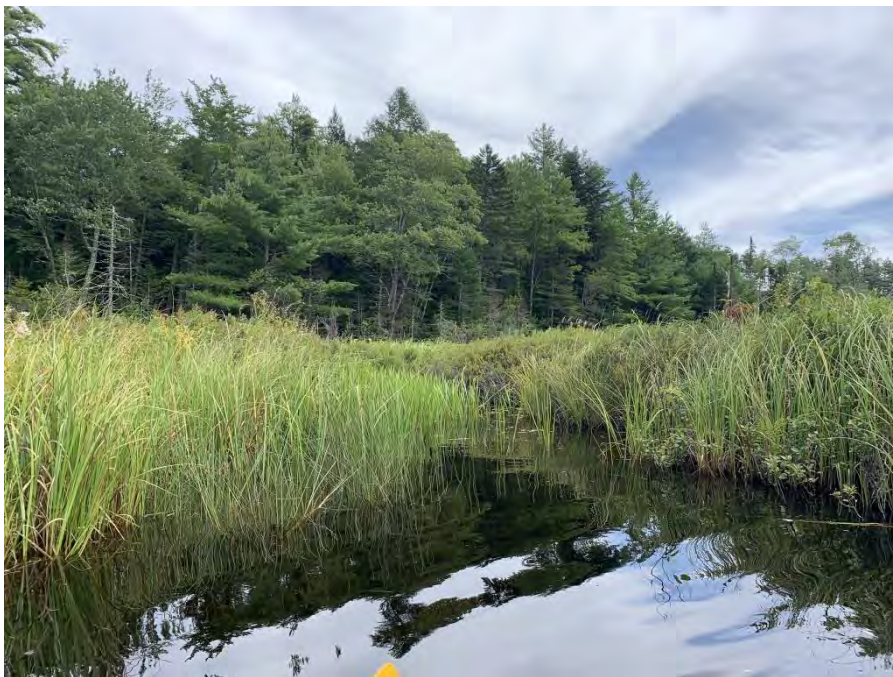
Photo 30. Many small tributaries connect to the main channel throughout Reach 3.

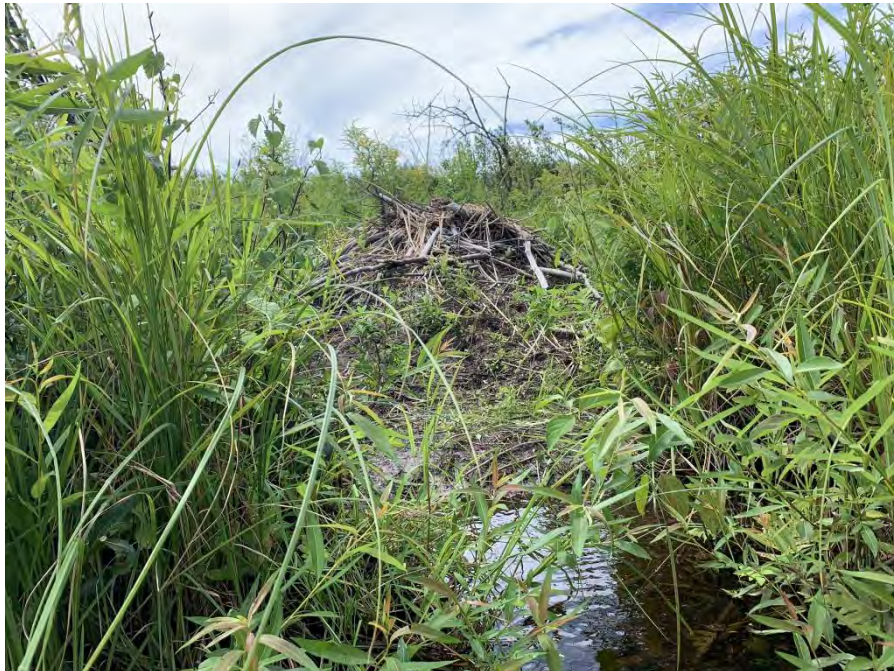
Photo 32. A beaver lodge was encountered within the upper section of Reach 3.

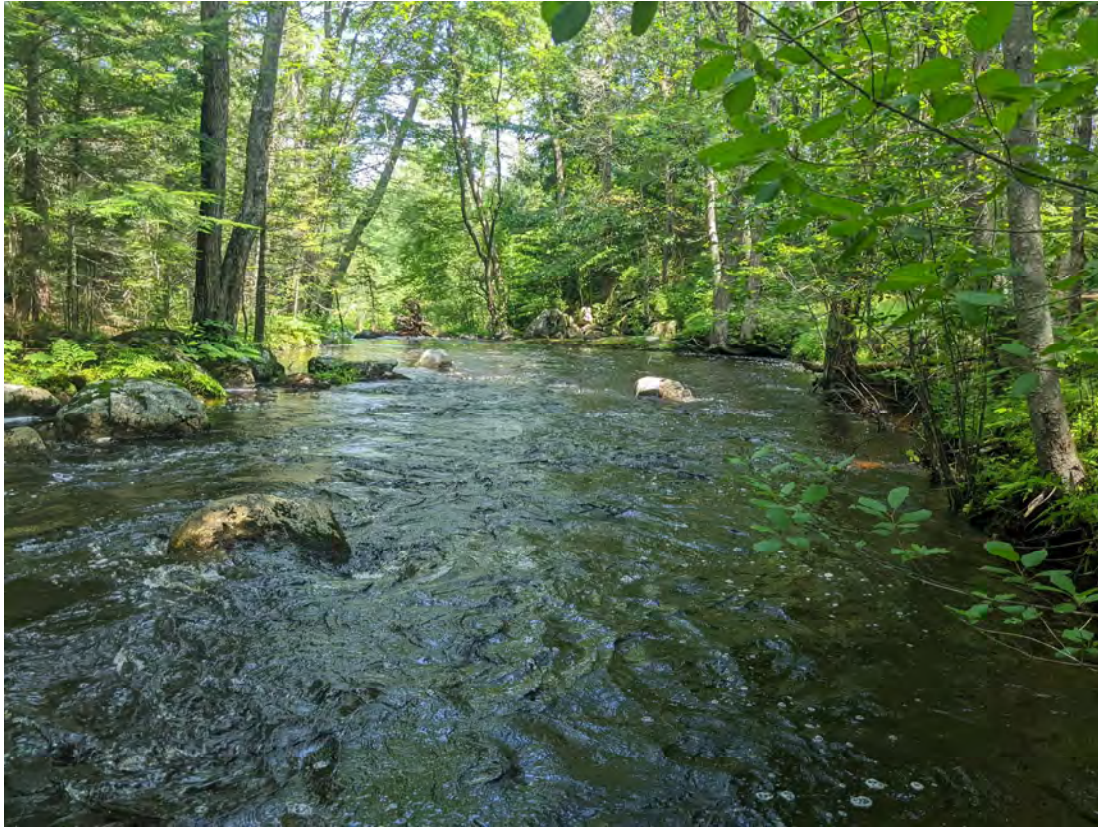
**Photograph 1:** Representative photograph of Melvin 5, downstream of bifurcation / realignment

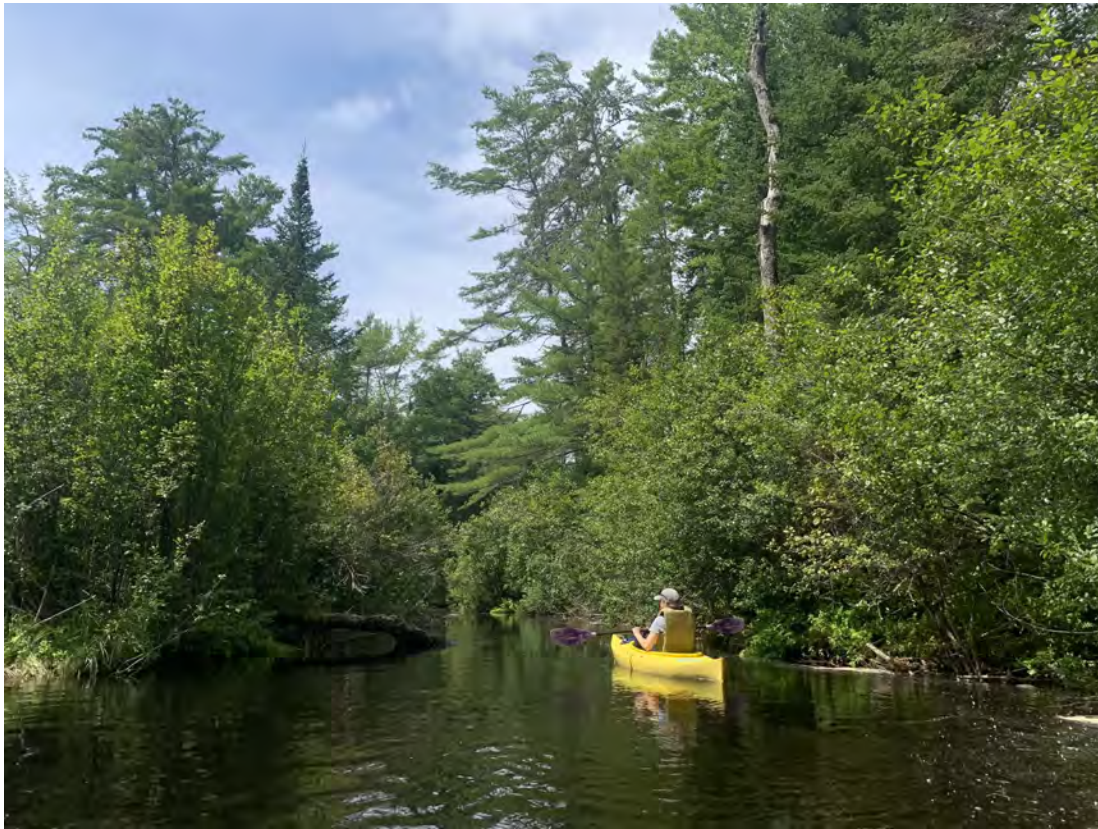
**Photograph 3:** Representative photograph of Melvin 4, note flatwater

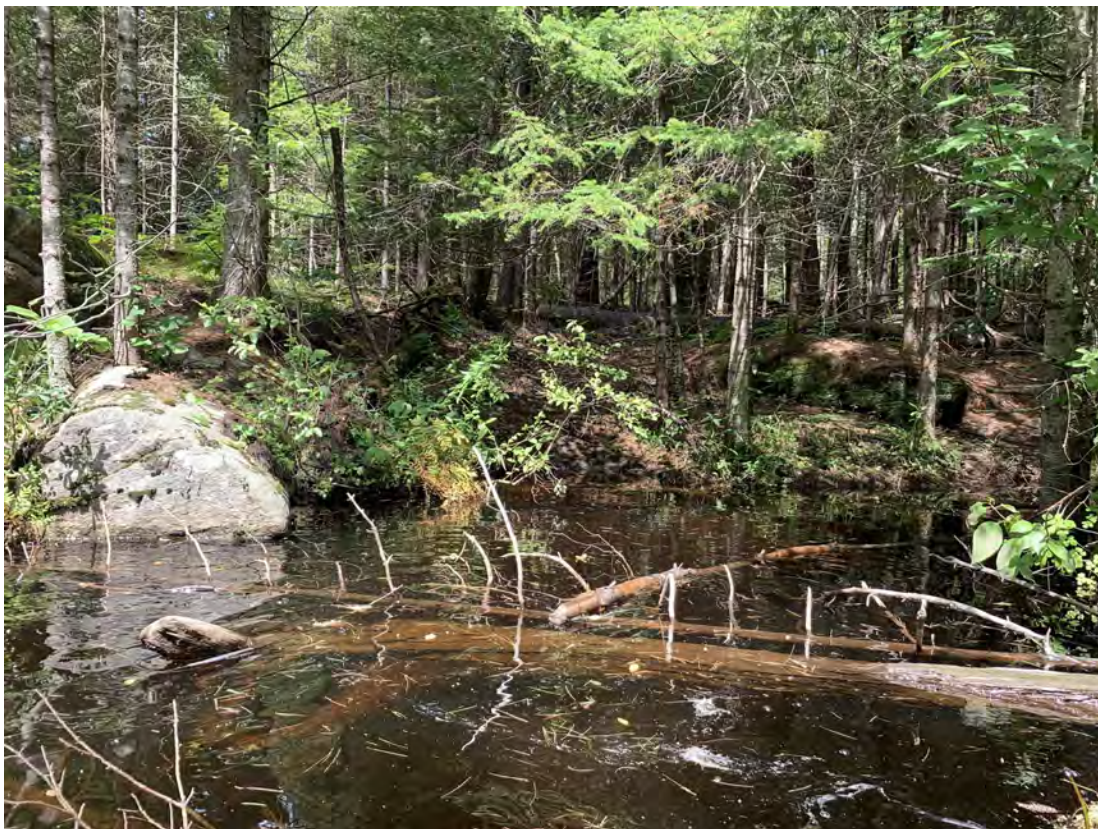
**Photograph 4:** Representative photograph of colluvial material and woody debris throughout Melvin 4

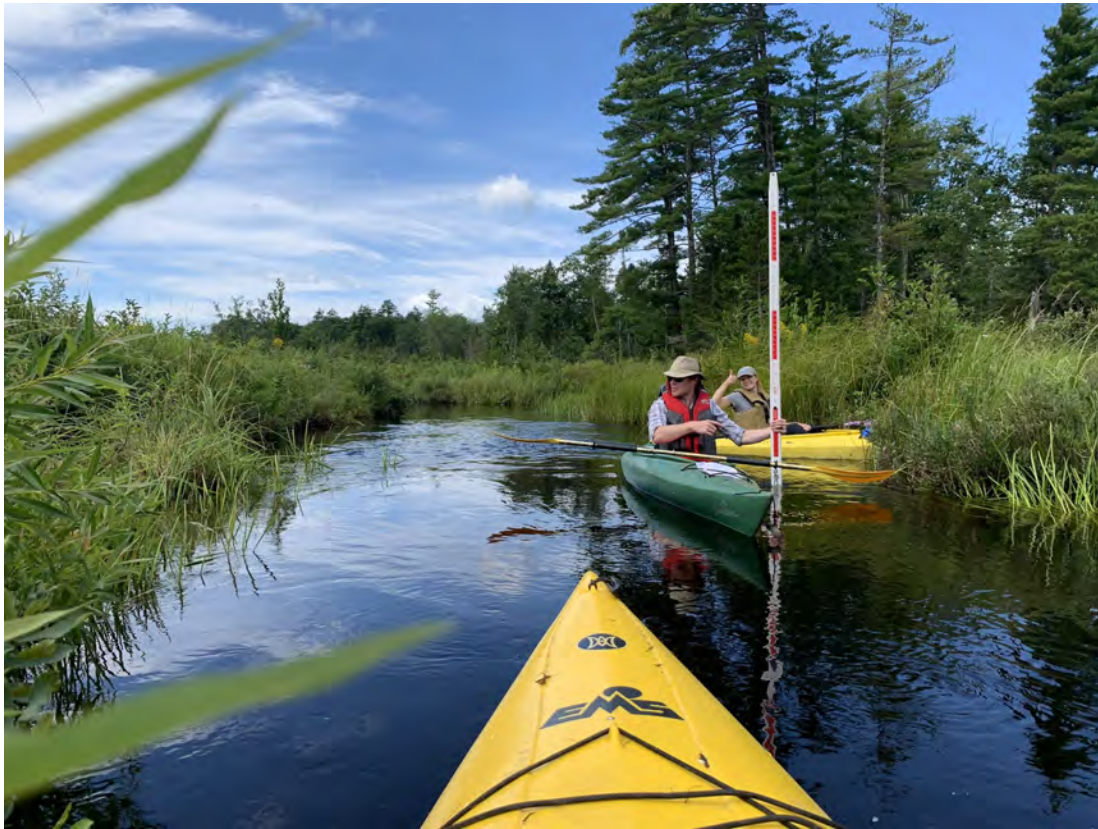
**Photograph 5:** Representative photograph of Melvin 3 upstream of New Road

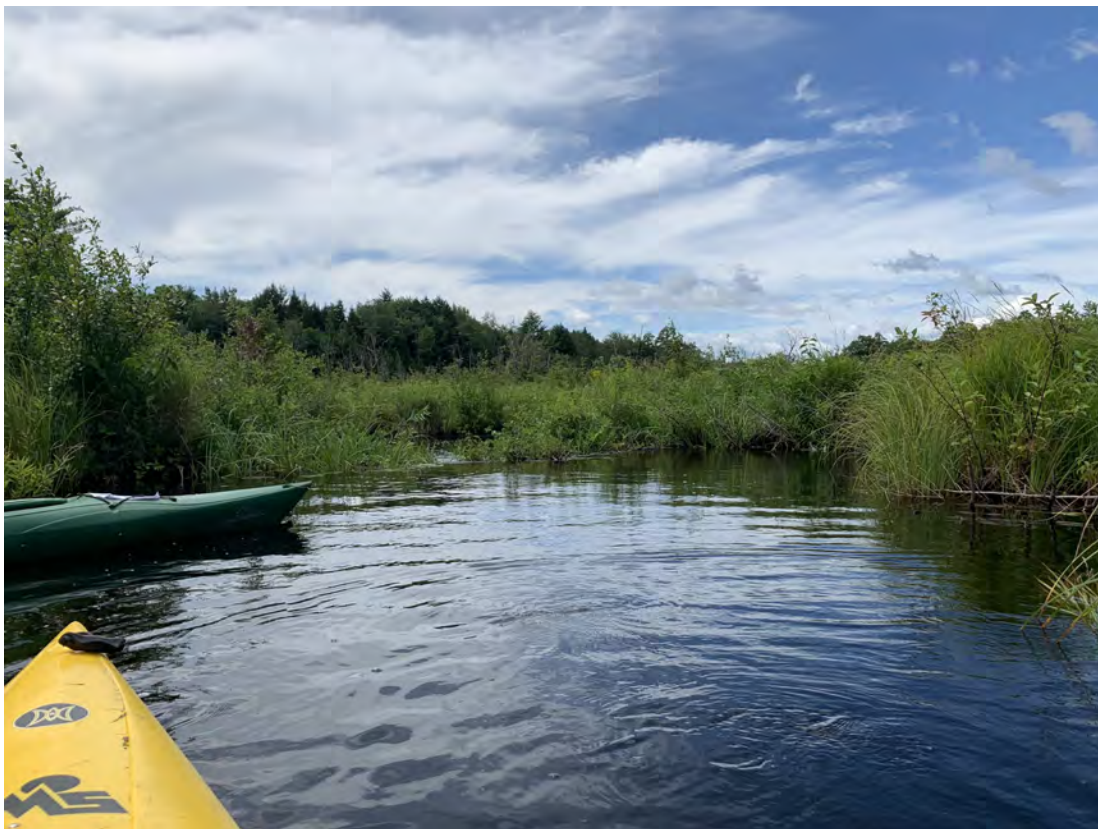
**Photograph 6:** Typical beaver dam frequent across Melvin 3 upstream of New Road

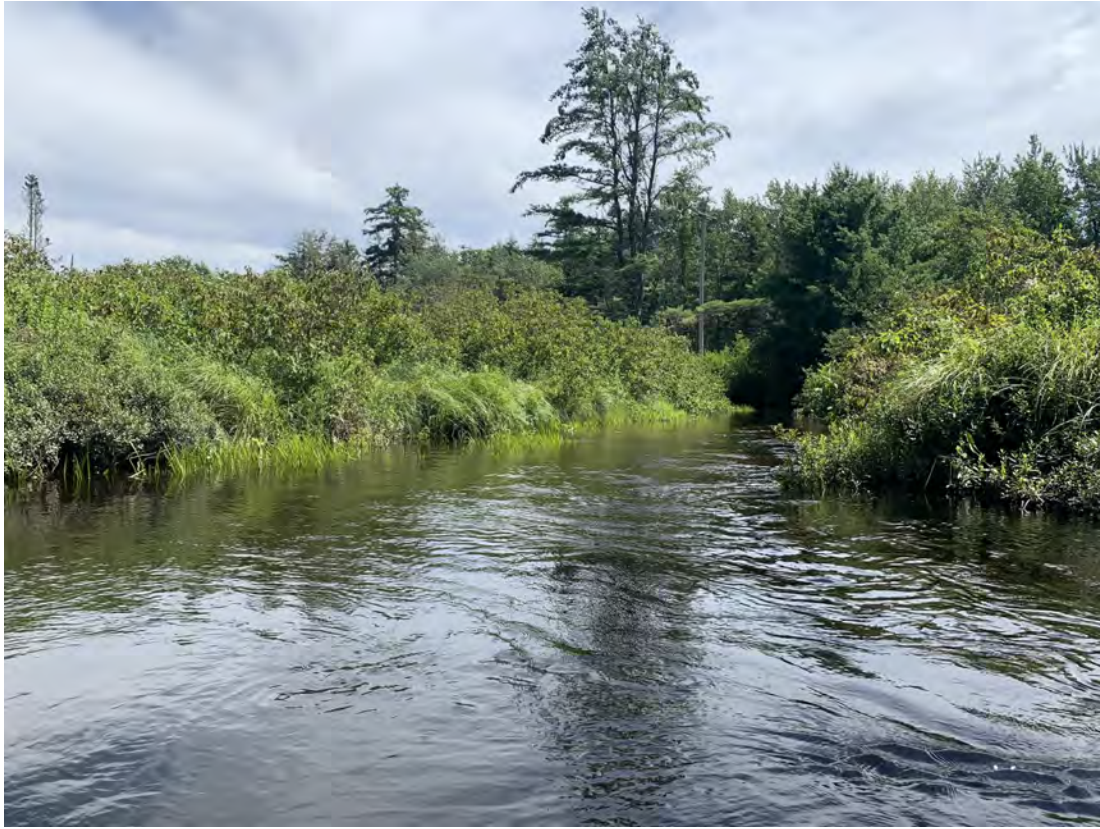
**Photograph 7:** Representative photograph of Melvin 3 downstream of New Road

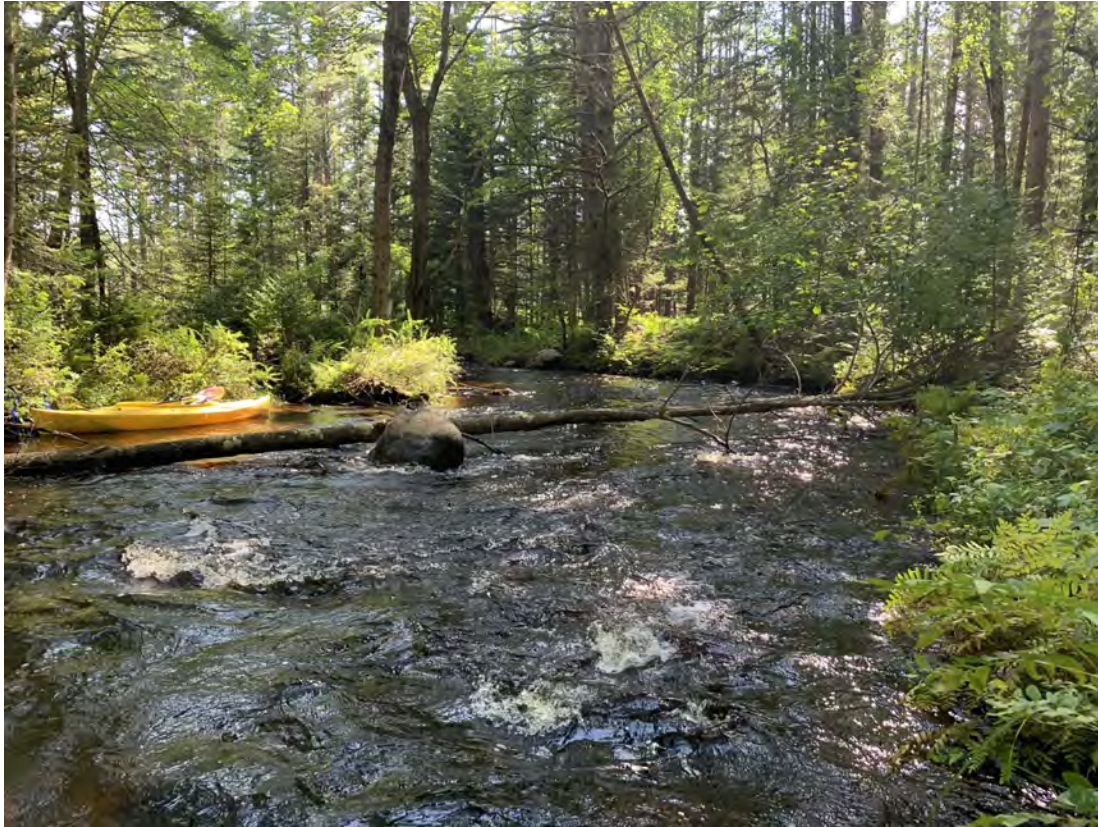
**Photograph 9:** Representative photograph of Melvin 2b

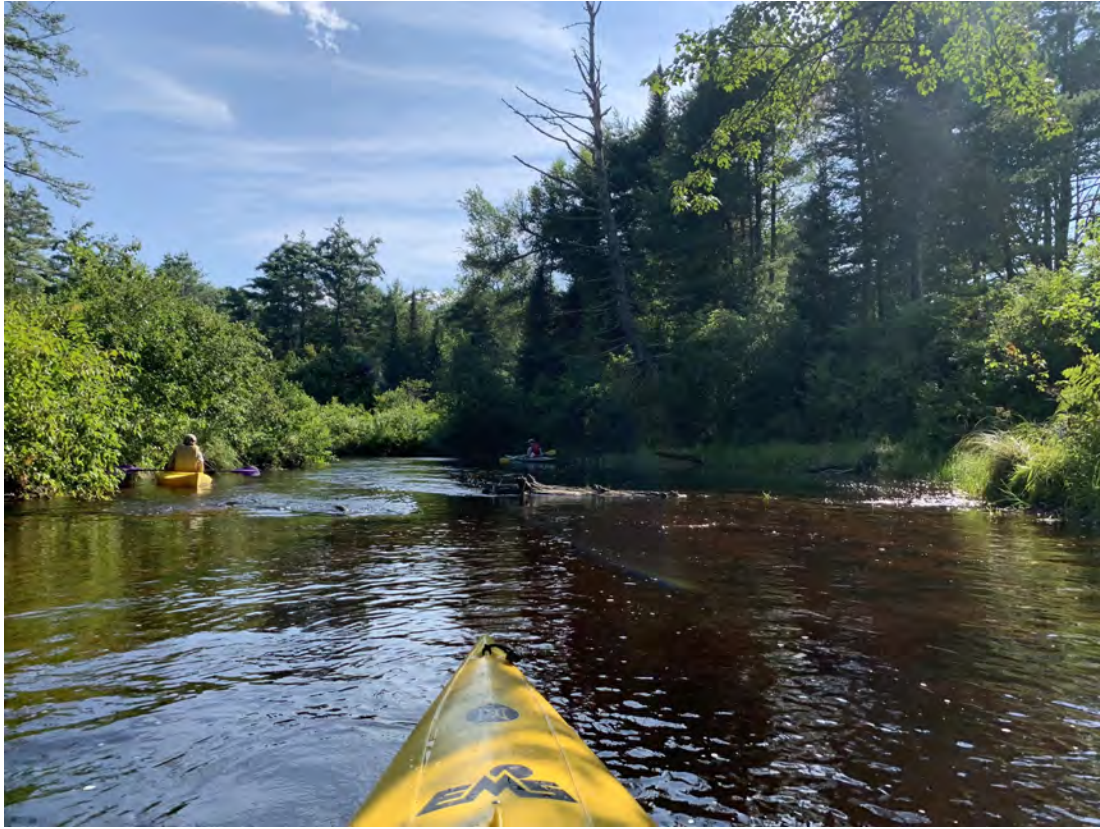
**Photograph 11:** Representative photograph of Melvin 2a, note woody debris

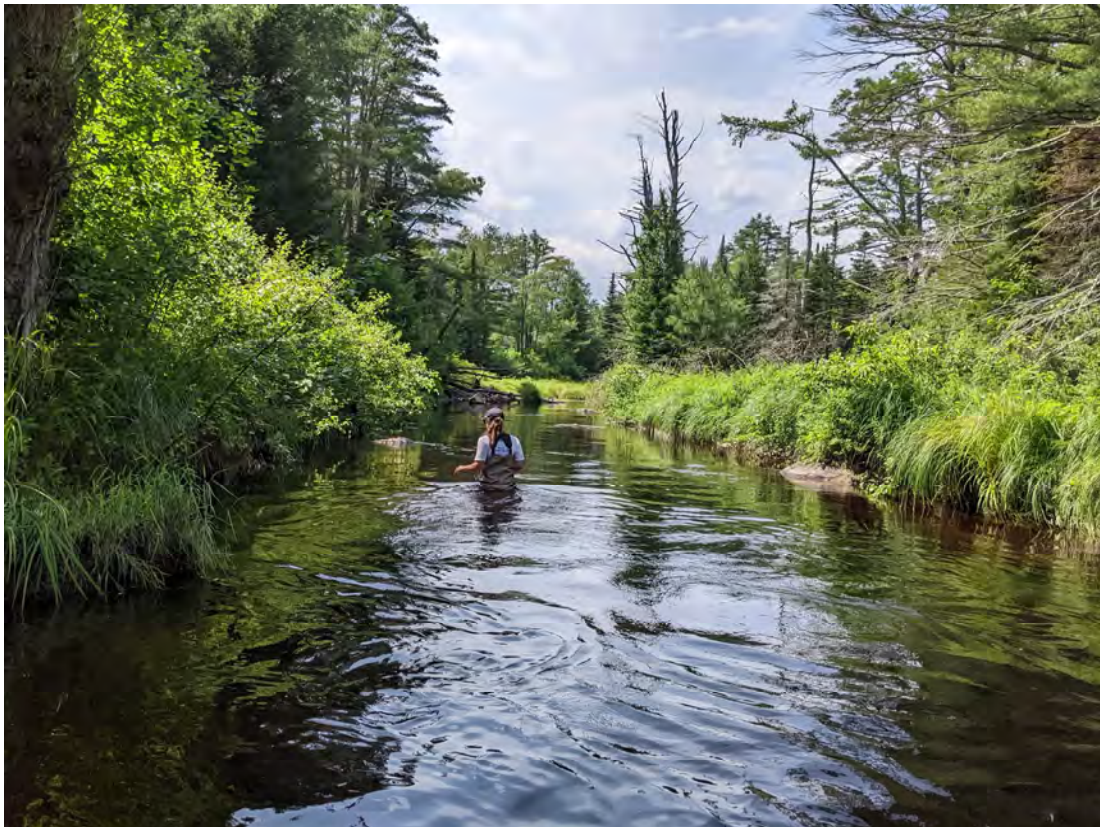
**Photograph 12:** Representative photograph of Melvin 2a, note variable water depths

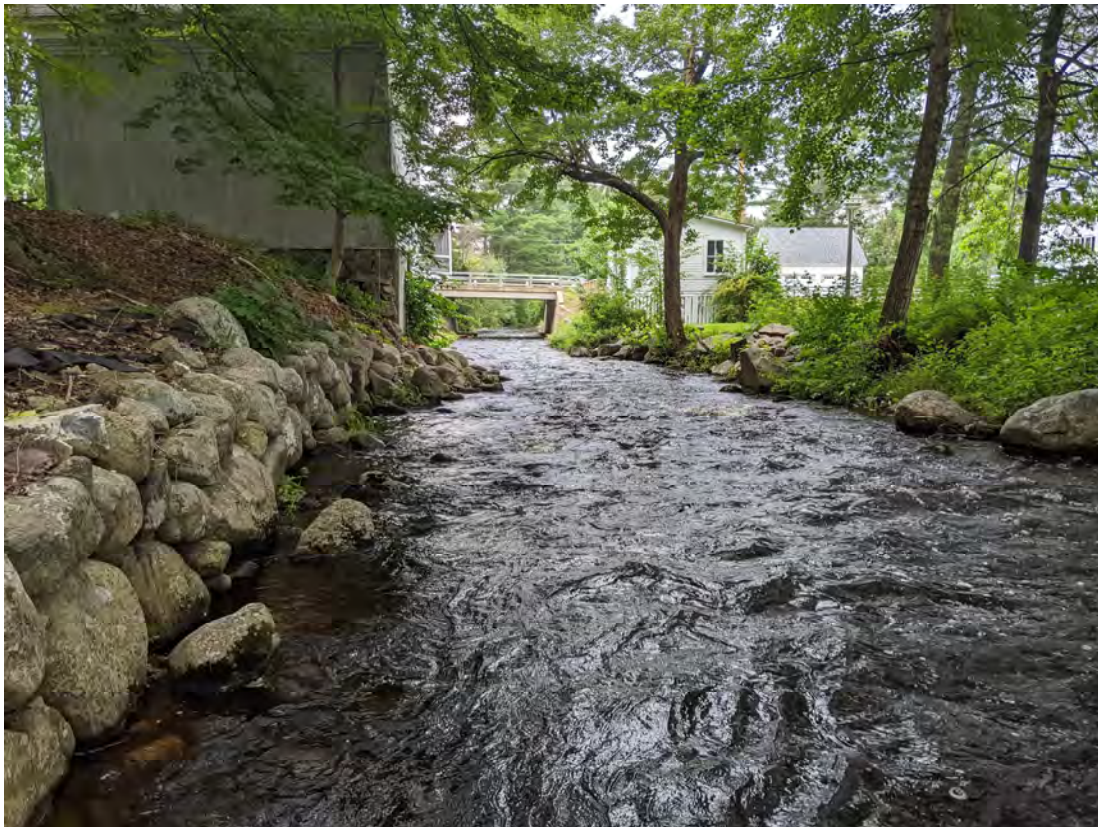
**Photograph 14:** Representative photograph of Melvin 1a, upstream of NH Route 109

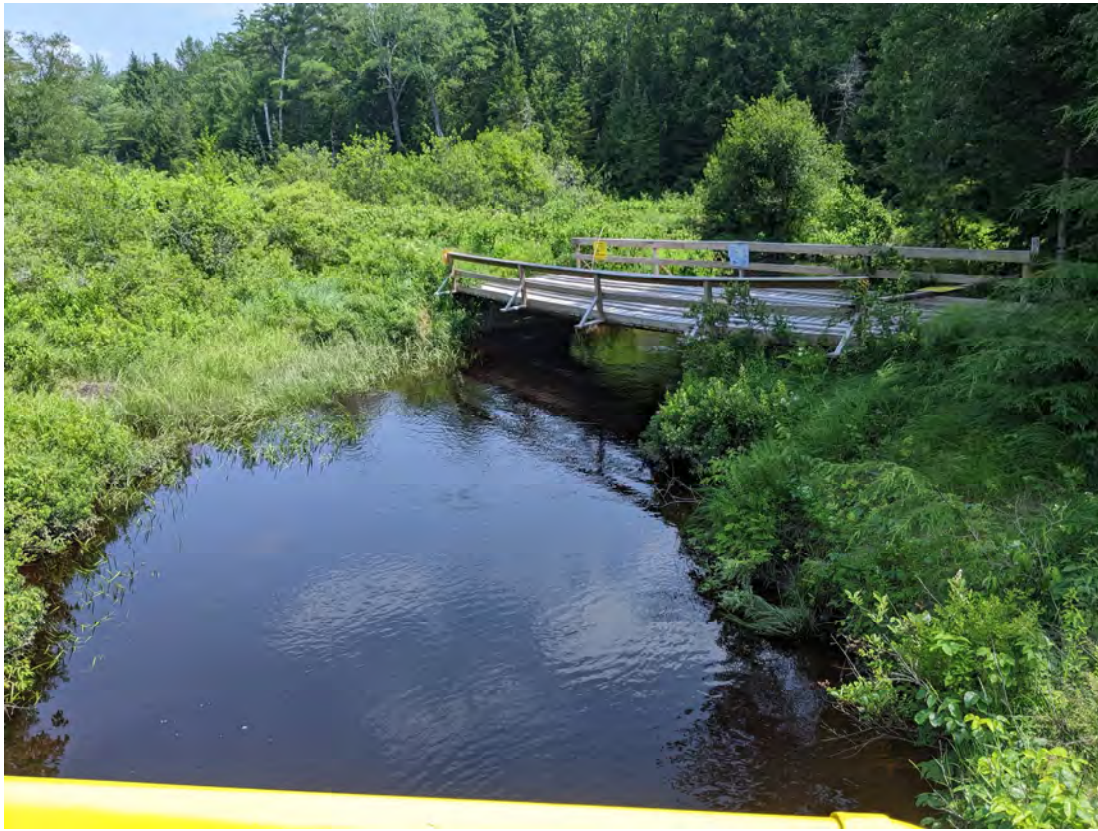
**Photograph 19:** Snowmobile crossing upstream of New Road

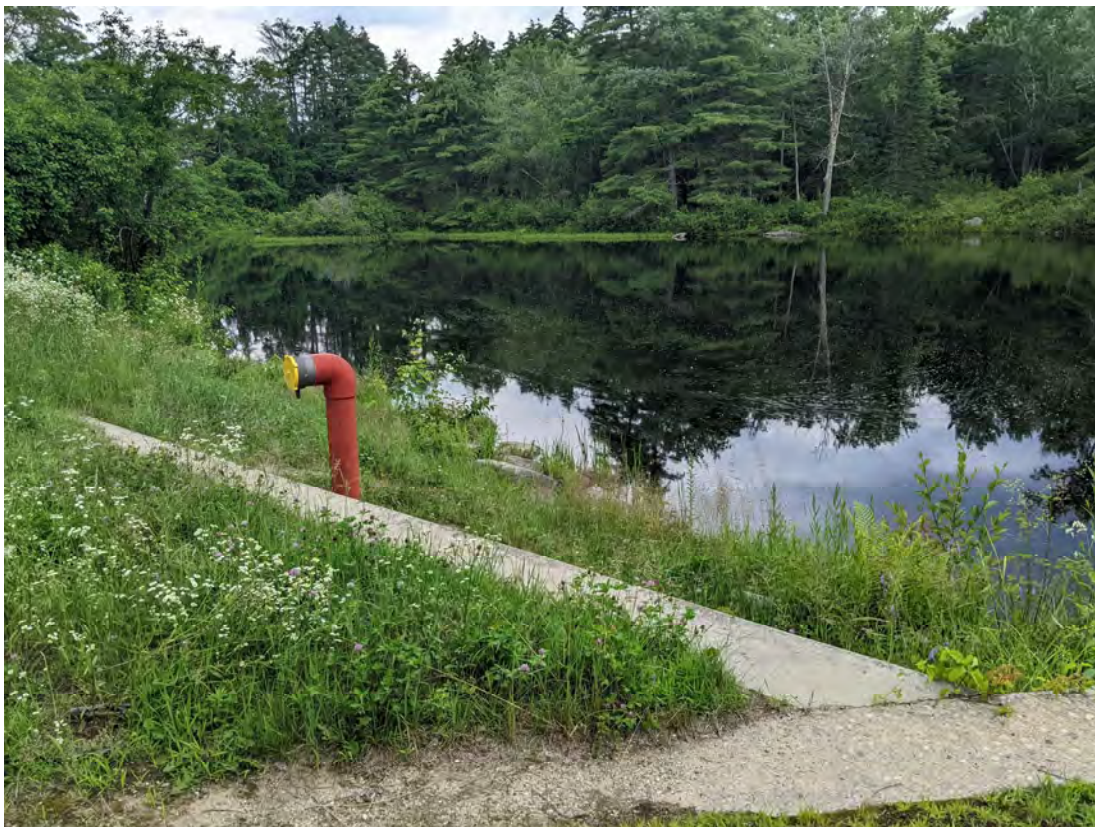
**Photograph 26:** Pope Dam impoundment

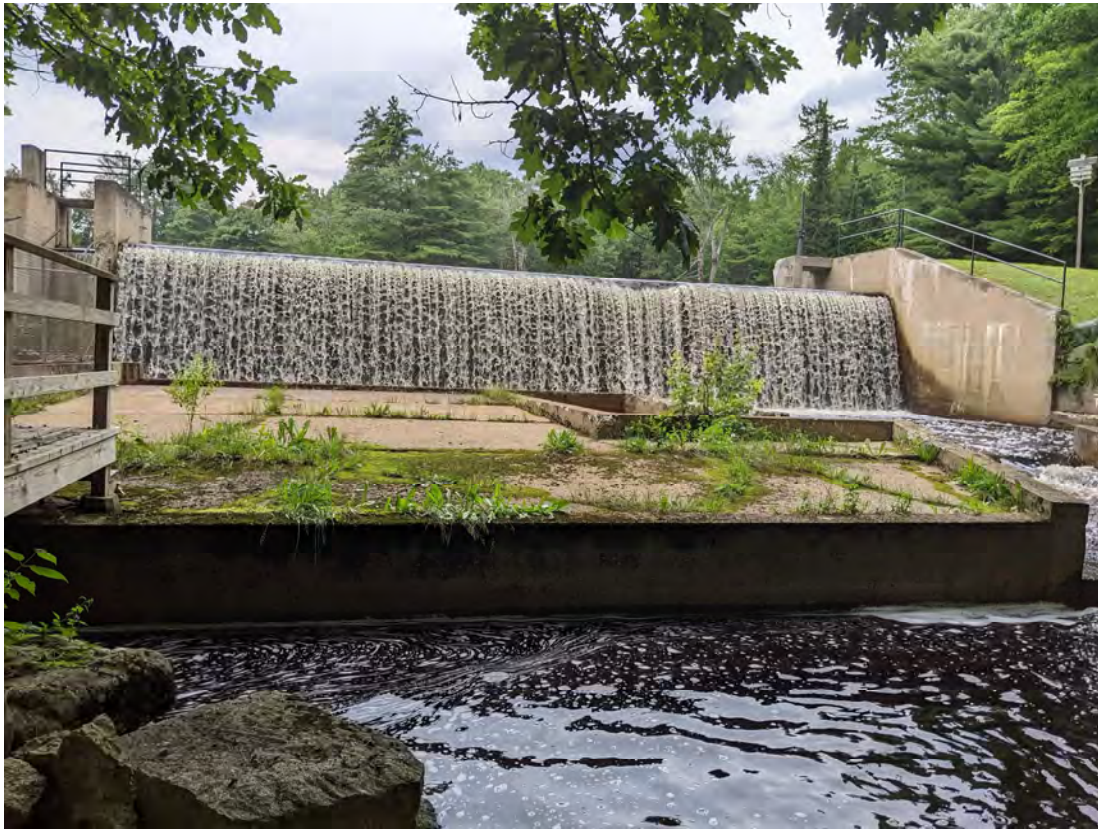
**Photograph 27:** Pope Dam

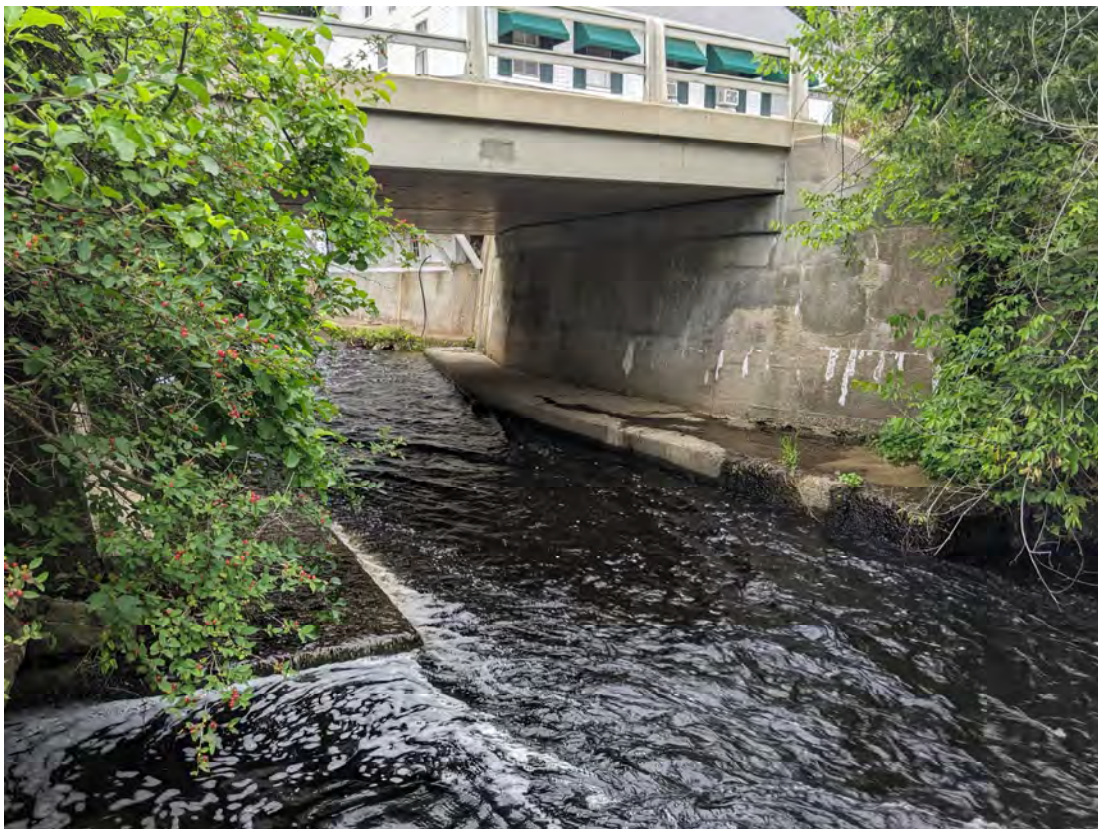
**Photograph 28:** NH Route 109 crossing of Melvin River
